Hybridization of Islands, Thailand

SITE VISIT REPORT KOH BULON DON

01/05/2017

ILF Consulting Engineers (Asia) Ltd

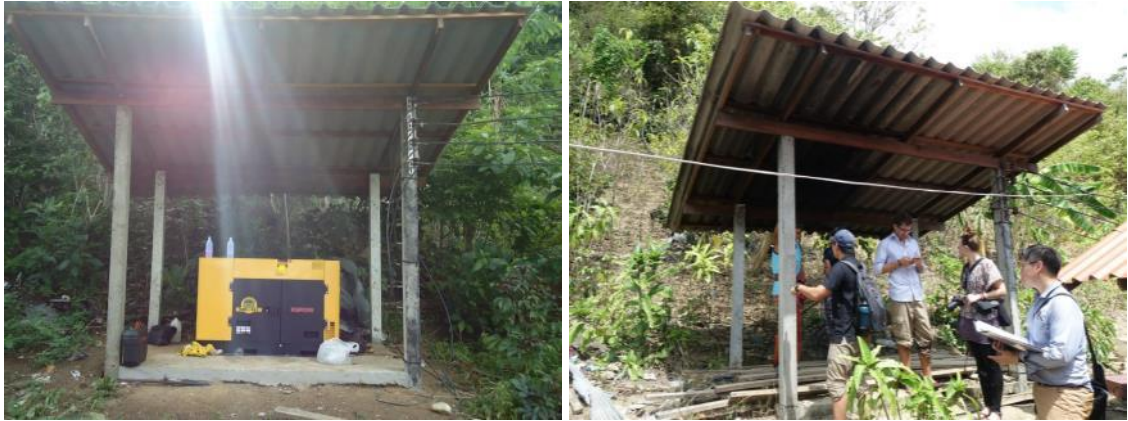
The generator, KIPOR KDE30SS3 26 kVA provided by the local government (SAO), together with the central grid transmission line were installed around 3 years ago and supplied the electricity for all of the households on the island. However, approx. 1 year ago, the generator failed after just 2 years of operation and shall be replaced by a new 50 kW generator (SAO applied for it) within the next months. The generator is housed in

an open powerhouse under a medium size corrugated sheet roof based on concrete poles as shown in Figure 5.

The generator used to be operated by a community team and was connected to the central grid transmission line with proper steel poles on the island. The generator was taken care of by Mr.Pun who was selected as operator during a community meeting.

Figure 5: Community generator on June 2014 (left) and on 1st March 2017 (right)

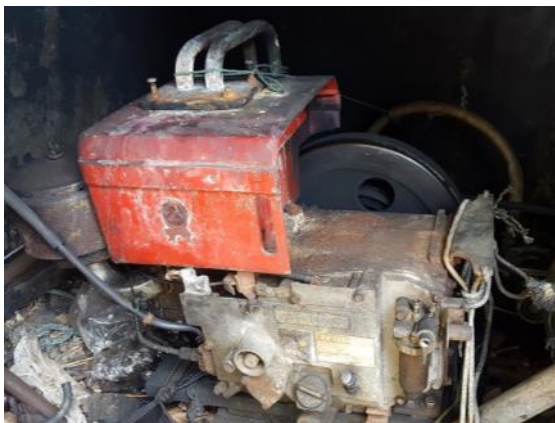
The generator is located at the far Southern side of the island. The generator type is YANMAR TF115–HM which has a maximum power of 8.5 kW. This generator is connected to 8 households. Diesel consumption is around 2.5 litres per night. The connected households are taking turns to buy the diesel every two nights.

Figure 6: Generator #31

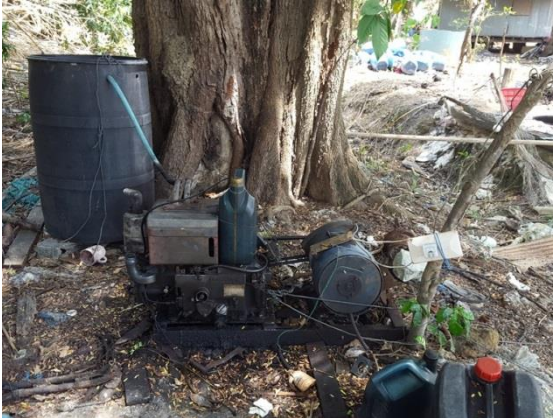
litres per night, powering 4 houses. It is operated by Mr. Pun who also set up the connection cables by himself.

Figure 7: Generator #32a under a tree

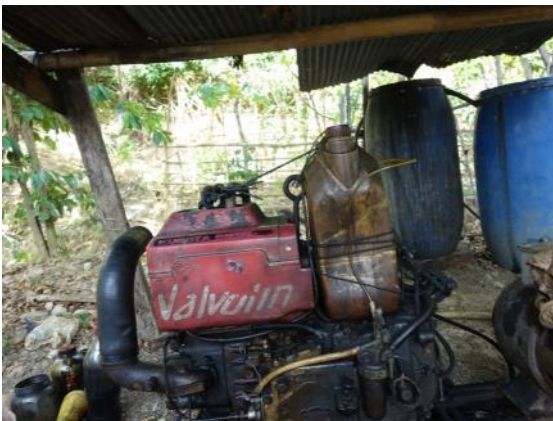
The generator is Valvolin, Kurota Diesel, 5D30 B. The nameplate of the generator was completely corroded, but the estimated power is 8 kW as informed by Mr. Lamli, who is the operator of this generator. There is no powerhouse. Therefore, the generator is placed under a small roof of welded brass. Diesel consumption is around 2.5 litres per night, powering 4 houses and a rest area.

Figure 8: Generator #33 under a small roof of welded brass

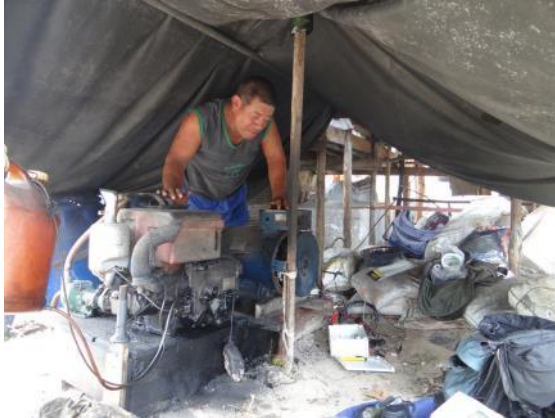
It shall be noted, that the load measurement device has been installed and measured the load of this generator as described in Chapter 7.1.

Figure 9: Generator #37 under a canvas

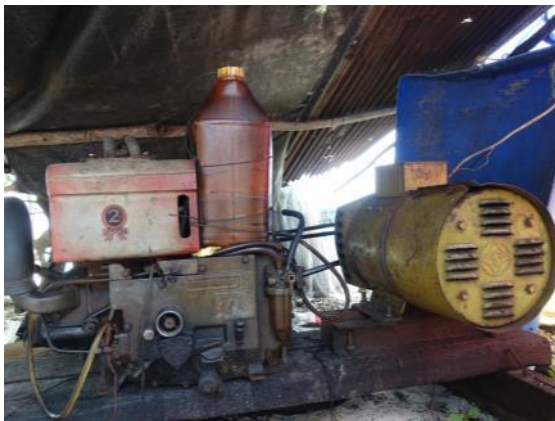
This generator is located in the East of the island. The engine brand is Yanmar and the electric generator brand is FOLK Alternators Co. of England. The power generation is 3 kW. There is no powerhouse; therefore, the generator is placed under a canvas with a small roof sheet. It is connected to a grid of 10 households. The local grid has been set up and operated even before the community generator was in operation.

Figure 10: Generator #38

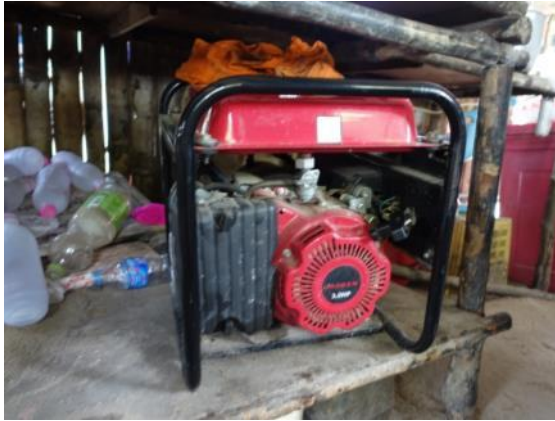
This generator is located next to the graveyard. The generator is Urogen 3.0HP which has power of 2.2 kW. There is no powerhouse. Instead, the generator is placed in a small shop/restaurant under a metal sheet roof. It supplies power to 1 household and 1 restaurant as needed.

Figure 11: Generator #40 in a small shop/restaurant under metal sheet roofs

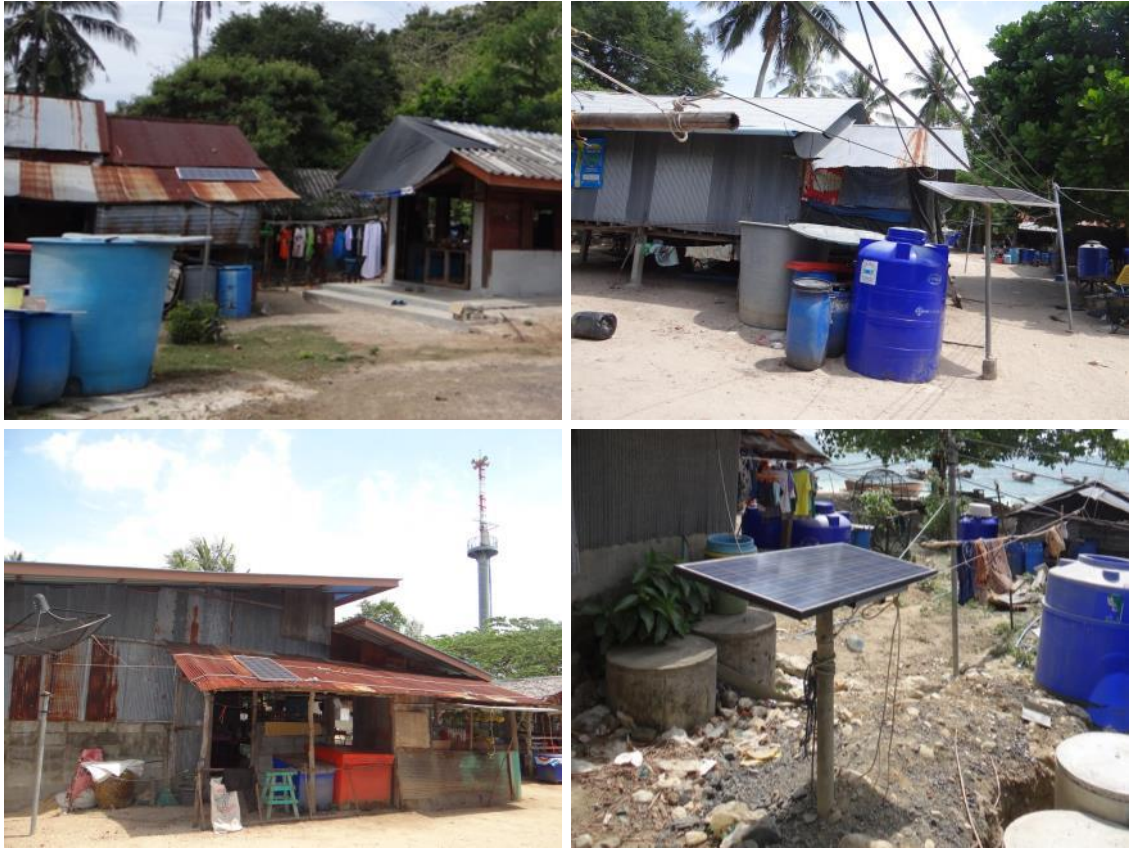
Around 20 Solar Home Systems (SHS) have been observed during the site visit. Some examples are shown in Figure 12. The PV modules are typically 130 W_p, made by Northern Sunshine. Different setups in each household such as various inclinations, various azimuths, installation types (rooftop or ground-mounted) were observed. Some households have SHS with batteries as shown in Figure 13.

Figure 12: Solar Home Systems observed on the island

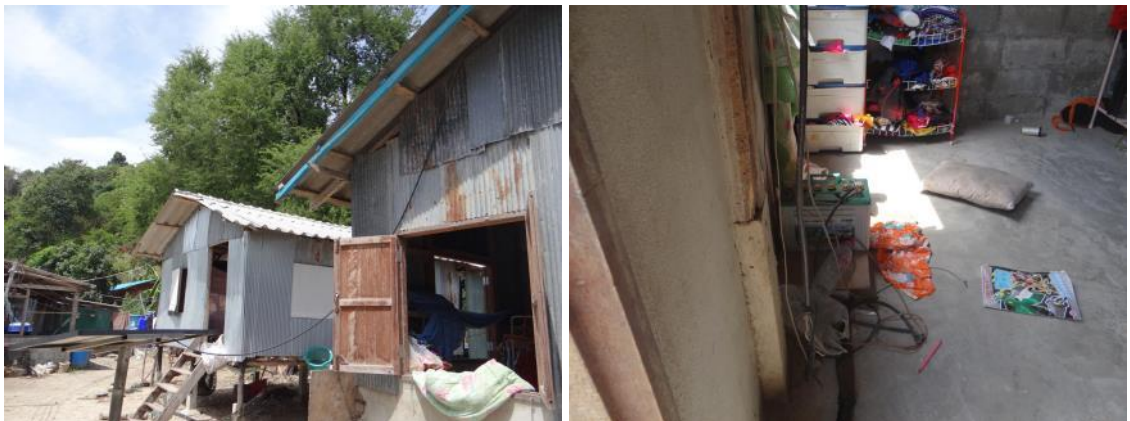
Figure 13: Households with Solar Home System and Battery

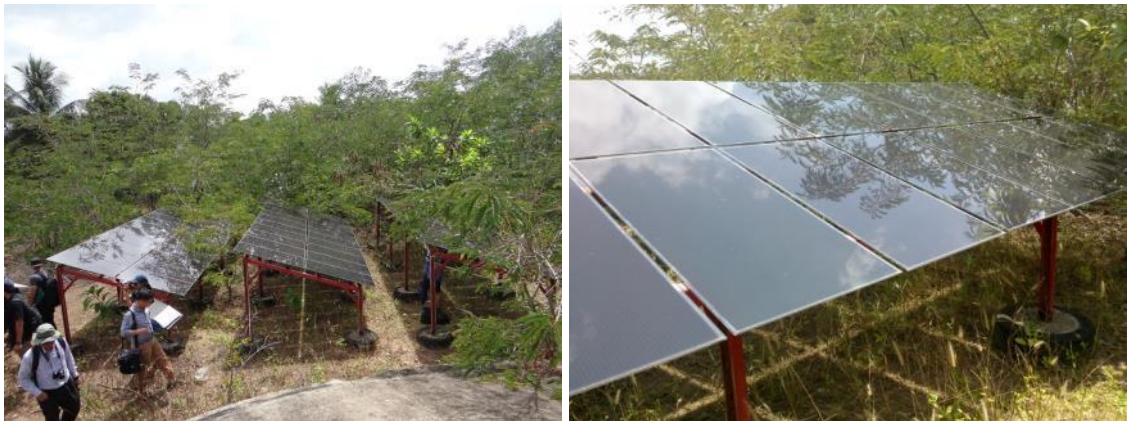
Figure 14 shows the PV system which was built in 2011 and used to supply the electricity for street lights. The system is located on a hill around 100 m west of the inhabited area. The system is currently not working. According to the information of the community representatives, the system broke down due to an overvoltage caused by a lightning strike. The Consultant cannot confirm, since no obvious signs of lightning strike have

been observed. However, the Consultant did not observe any installed lightning protection.

The system's azimuth is facing South West with 210° and an inclination angle of 20°. It comprises of 60 modules (three tables, 20 modules/table) of Bangkok Solar (BSC) 50 W_p thin film modules, totalling 3 kW_p. The size of the installation is approximately 6.5 m × 10 m. There is no additional space for new modules available as the area is titled as National Park, therefore, trees and vegetation shall not be cut. The replacement of the existing system could be an option. The modules are shaded caused by the surrounding trees in the Eastern and Southern direction. Far shading may also occur caused by the mountain toward the West.

Figure 14: 3 kW_p PV system located next to water storage

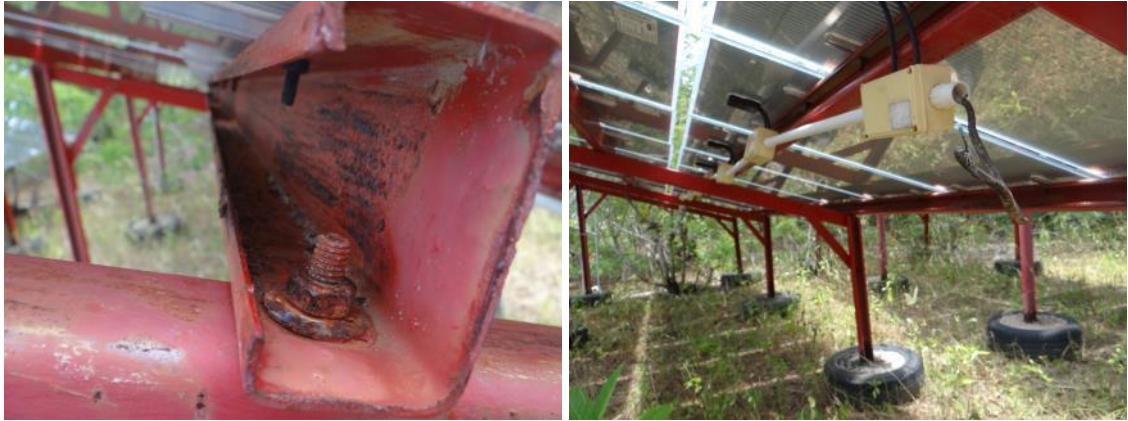
Rusty metal of a mounting structure has also been observed as shown in Figure 16.

Figure 16: Rusty metal [left] and disconnected cable [right]

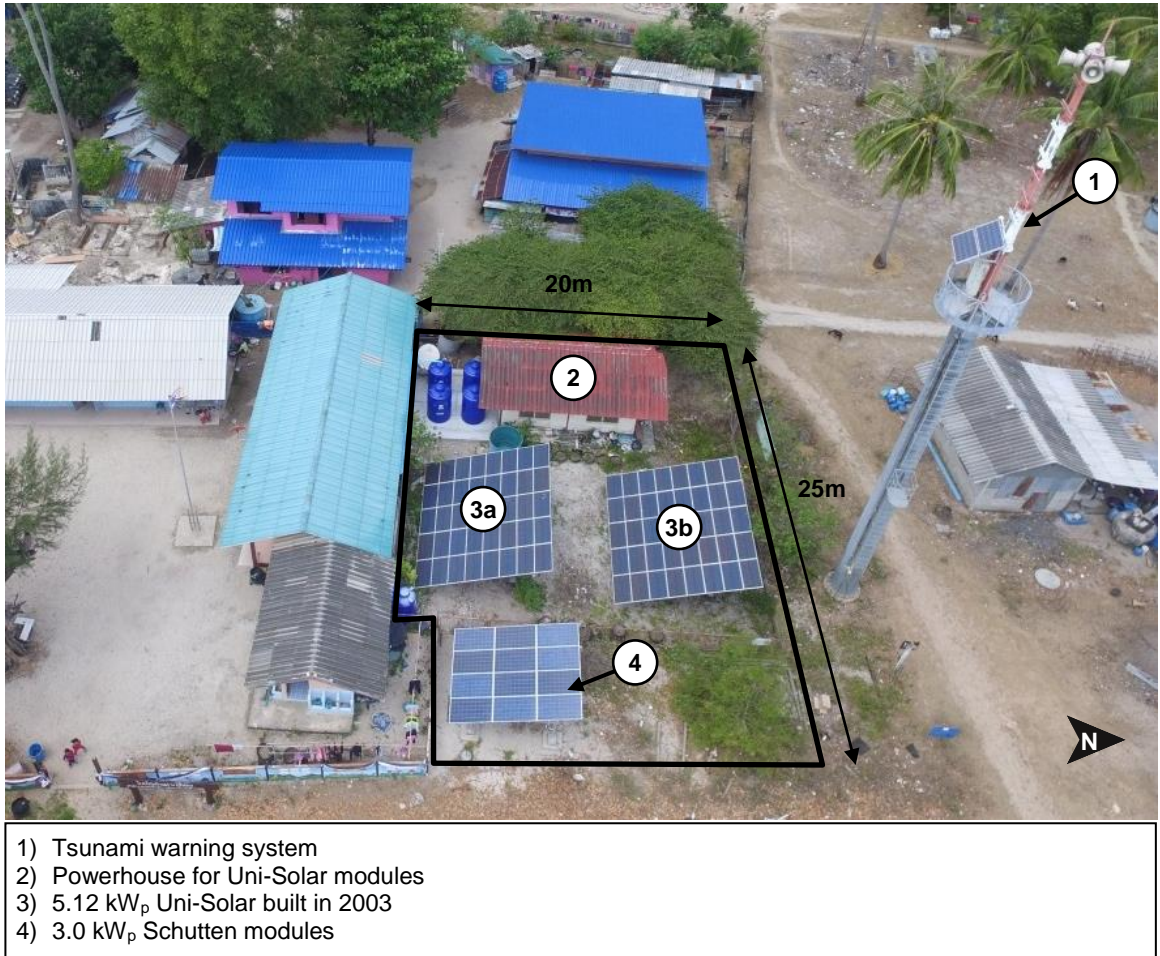
The building close to the PV system causes some shading of the modules. The distance between the PV table (No.3a) and the school building is approximately 1 m and the school building's lowest height is around 3 m.

Figure 17 also shows the tsunami warning system with two PV modules to supply electricity.

Figure 17: Overview of PV system located within school area

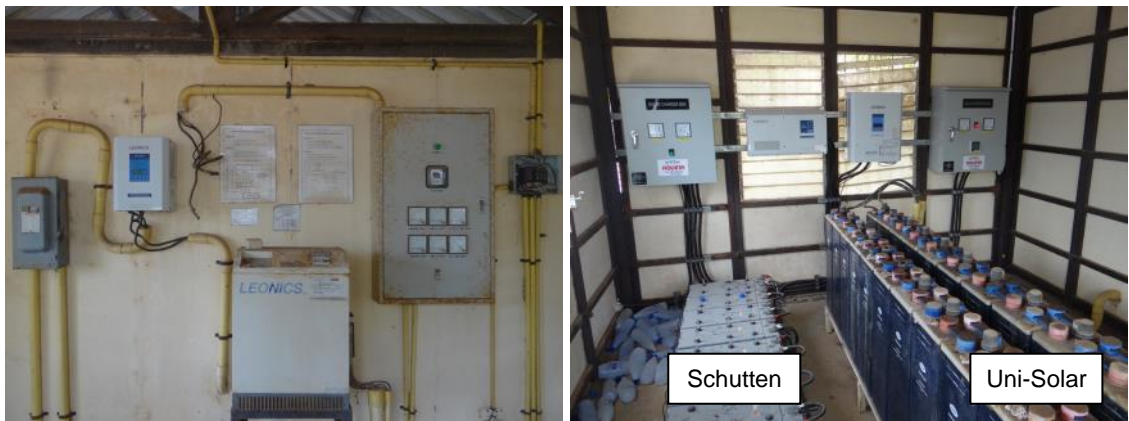
Figure 18: Inverter and batteries system inside powerhouse

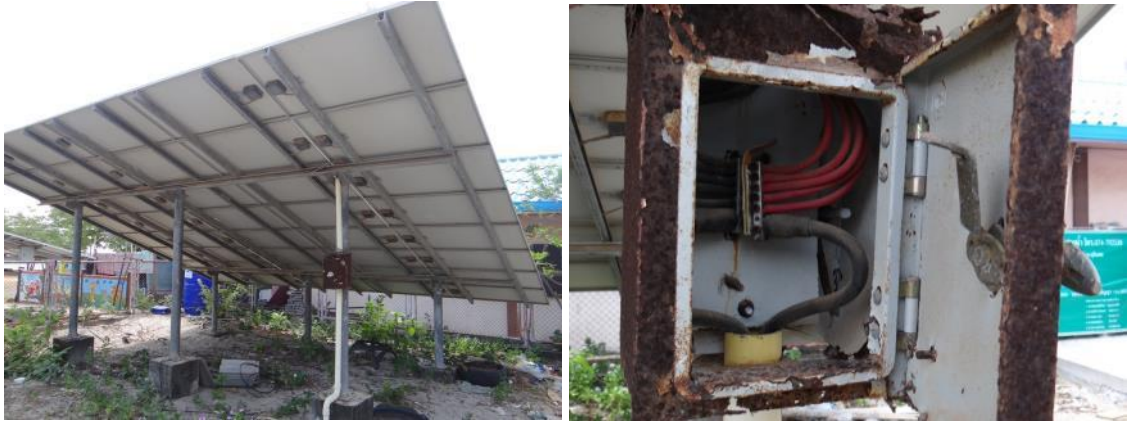
Figure 19 shows a severe rusty combiner box. It can be presumed that the material is not corrosion resistant and suitable for the application.

Figure 19: Rusty combiner box

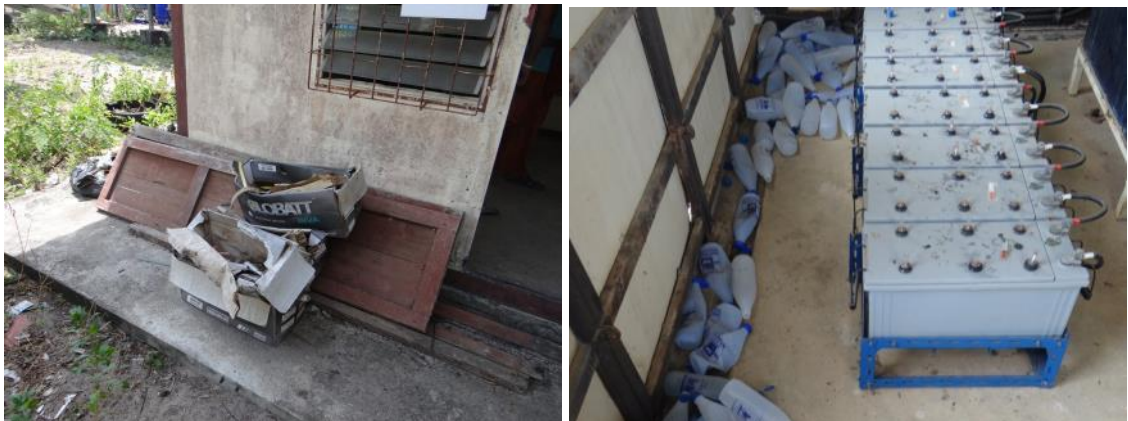
Garbage, such as battery packaging and distilled water bottles for battery refilling, is not well-organized in the powerhouse as shown in Figure 20.

Figure 20: Unorganized garbage in the powerhouse

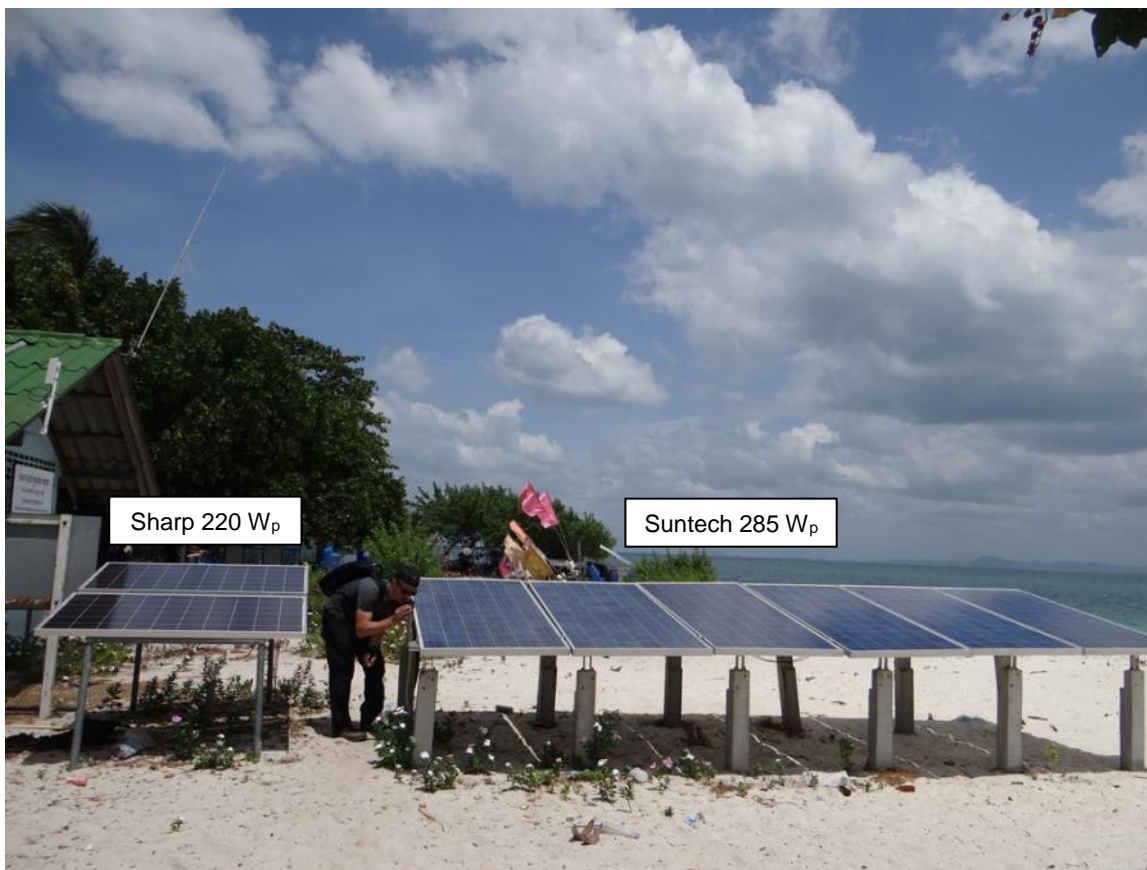
Figure 21 shows two PV modules of Sharp 220 W_p (not in-use) and six PV modules of Suntech 285 W_p totalling 1.71 kW_p (in-use). The Suntech system was built in 2014 supplying the electricity for the public health centre only. The system is facing South (180°) with an inclination of 15° . The PV modules are connected via charge controller to 4 batteries of Globatt model 190H52R (specification of battery: nominal voltage 12V, capacity 200 Ah) as shown in Figure 23.

Figure 21: Two PV modules not in use [left], 1.71 kW_p PV system for health centre [right]

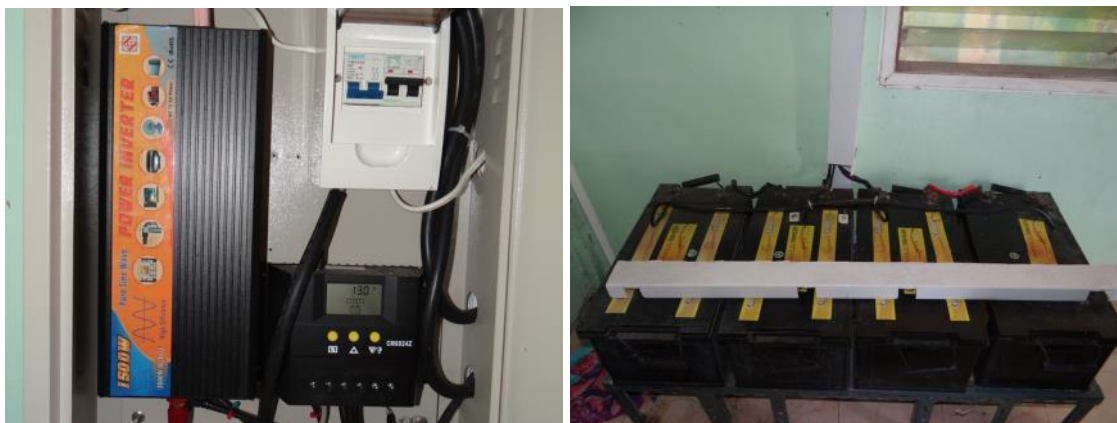
Figure 22: Inverter and charge controller [left], four Globatt batteries [right]

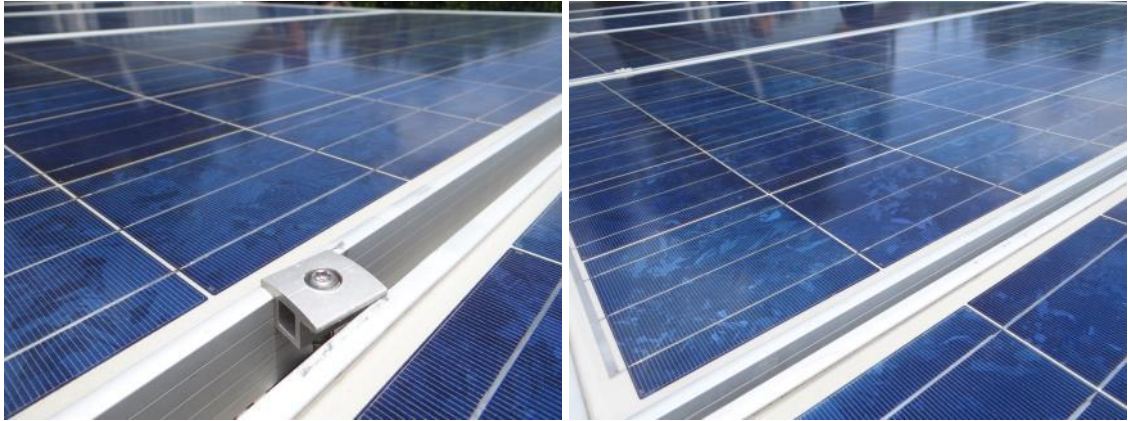
Figure 23 shows the installation of the Suntech system. Loose clamps and a missing clamp can be observed. As shown in Figure 24, the combiner box is not properly organized and the mounting structure is damaged.

Figure 23: loose clamp [left], missing clamp of PV module [right]

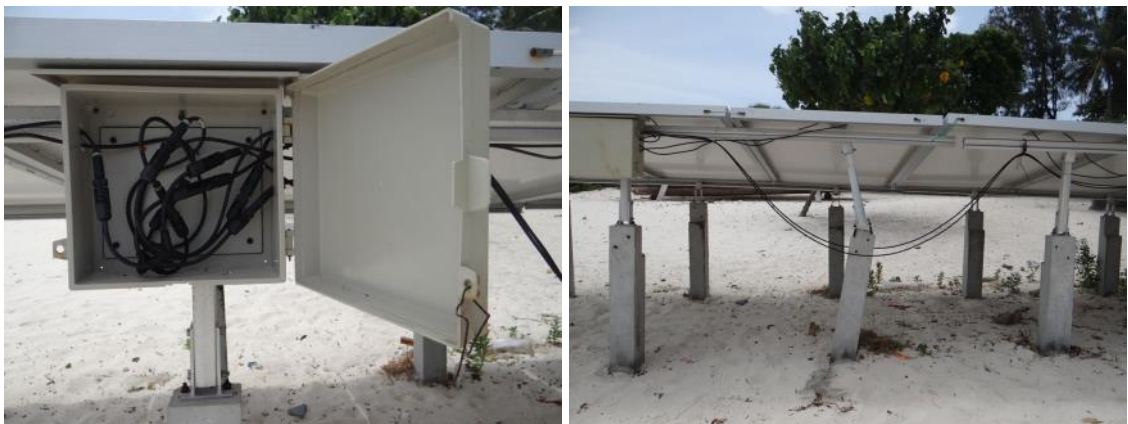
Figure 24: Untidy combiner box [left], damaged mounting structure [right]

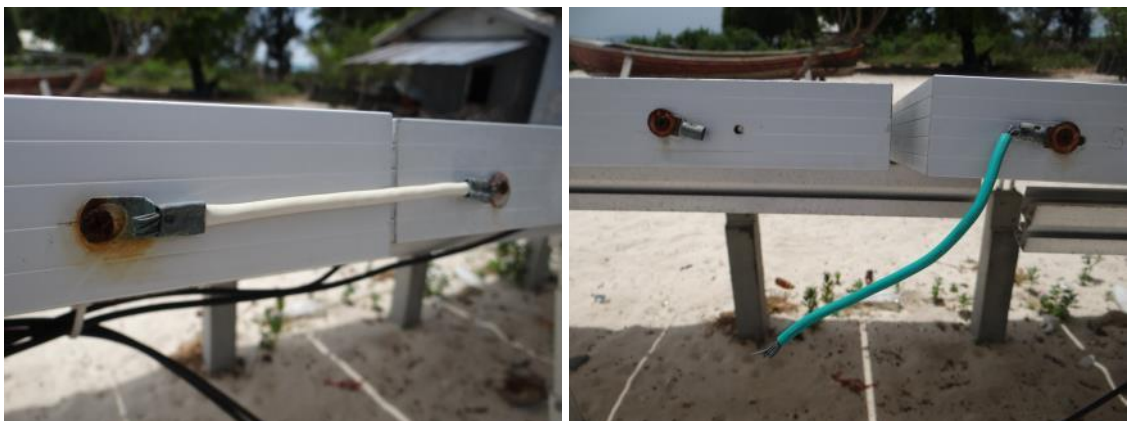
Rusty screws are observed and the grounding cable is disconnected as shown in Figure 25.

Figure 25: Rusty screws [left], disconnected grounding cable [right]

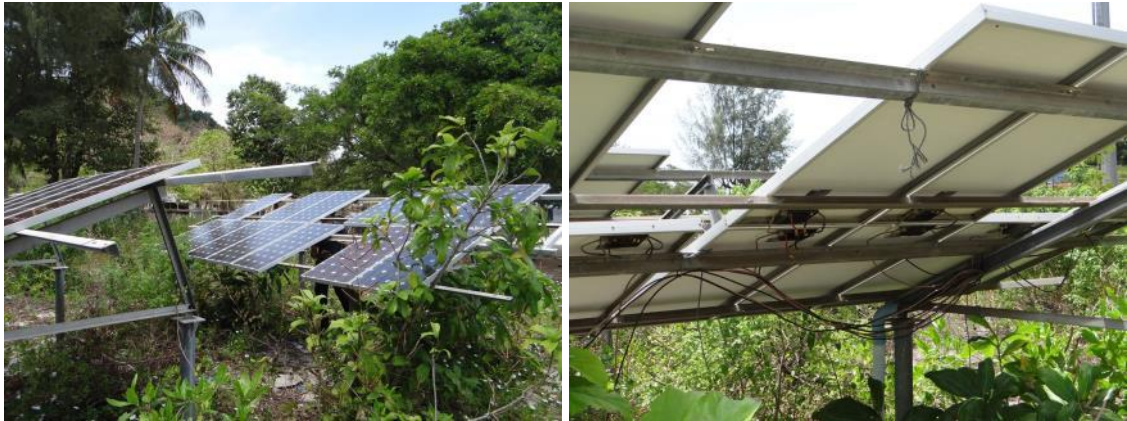
Figure 26 shows an abandoned/broken PV system with unknown specification. The system was installed to supply a charging station, where villagers could charge their private batteries.

Figure 26: Abandoned PV

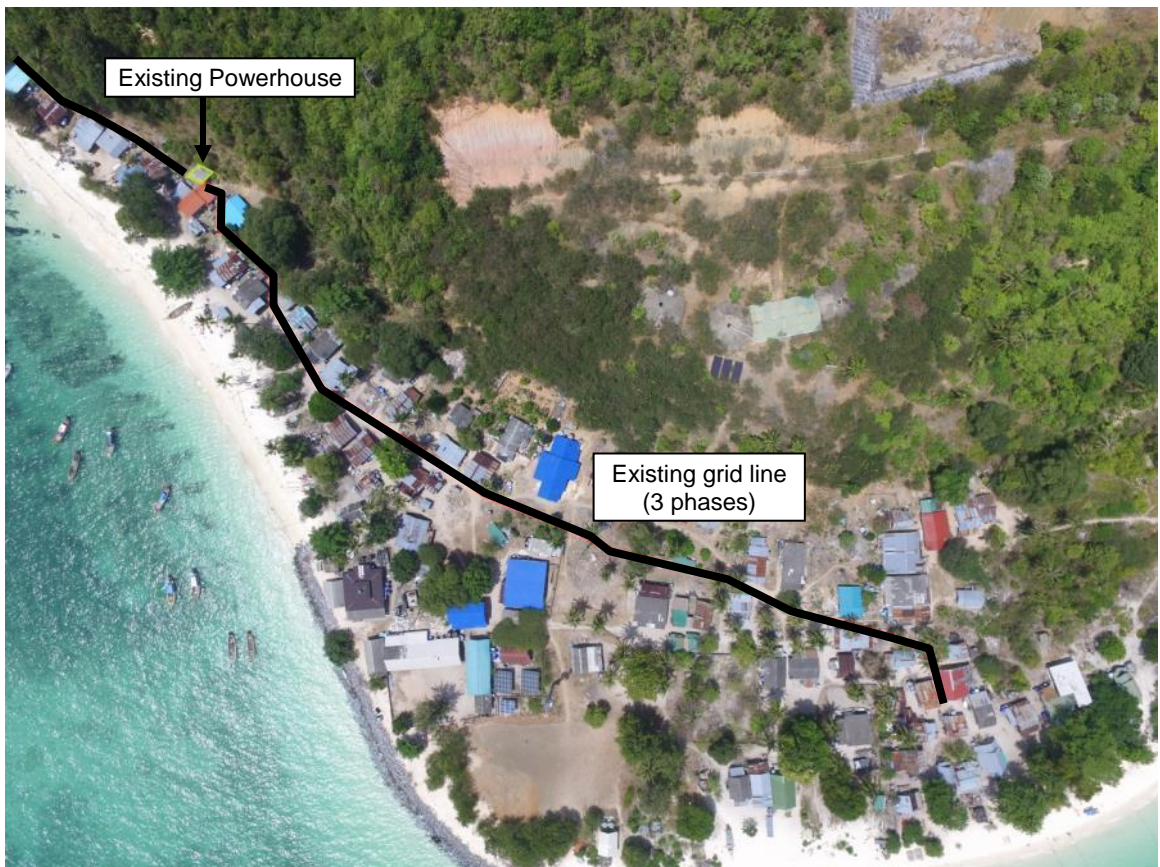
This grid was installed around three years ago by the Sub-District Administrative Organization (SAO) as shown in Figure 27. Individuals had to purchase and provide the tapping equipment and cable to connect to the main grid. The grid is currently not in-use because of the broken community generator. This grid uses the 50 mm² THW-A cables (3 phase, 4 wires) as shown in Figure 28. The insulation of the cables is in a good condition.

Figure 27: Existing central grid transmission route

It has to be noted that the central grid might be used for the hybrid system. However, extension of this grid shall be considered, to cover the whole island.

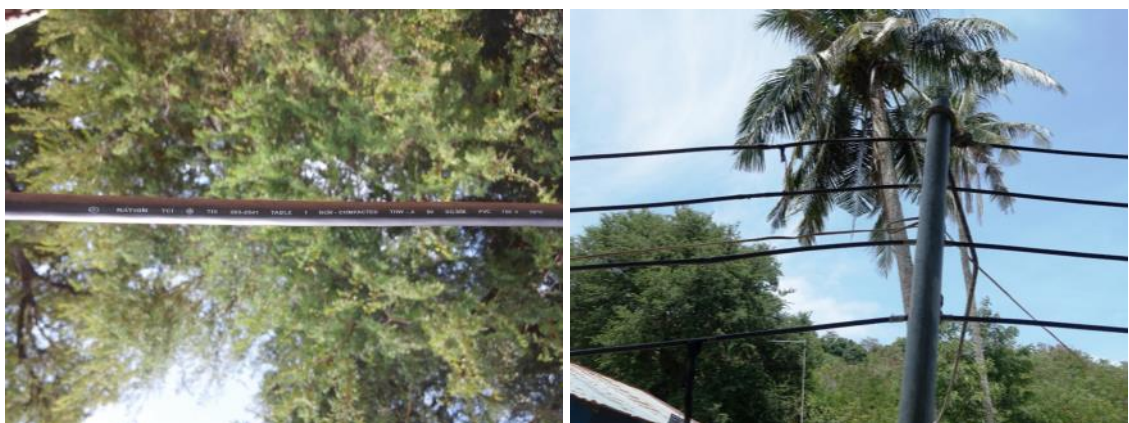
Figure 28: THW 50 mm² cable (Existing central grid transmission line)

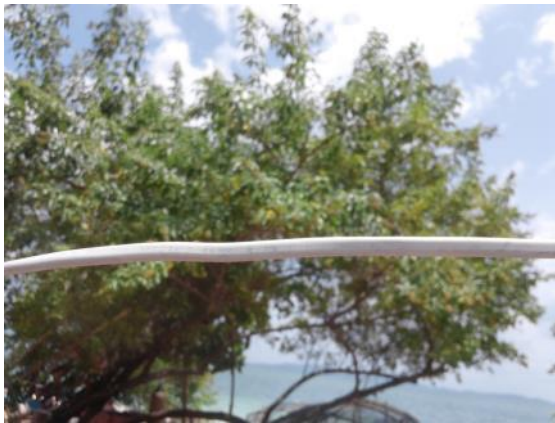
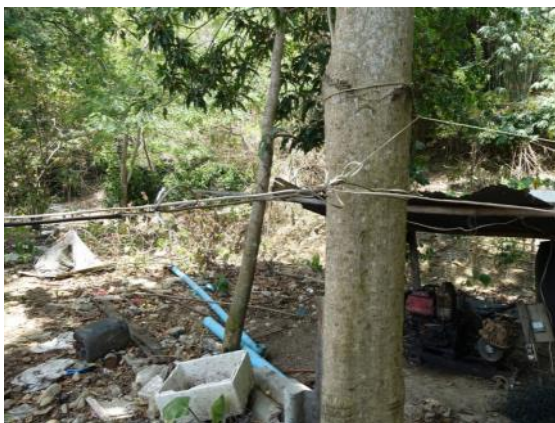
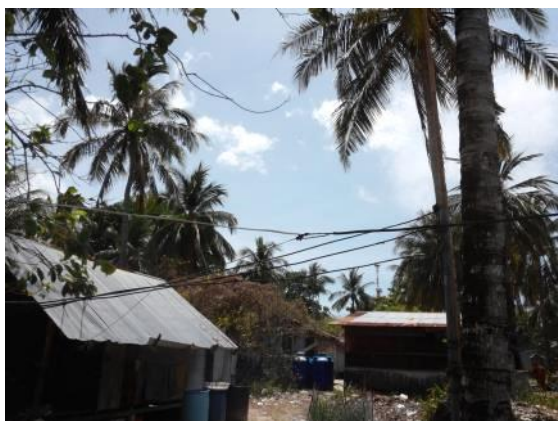
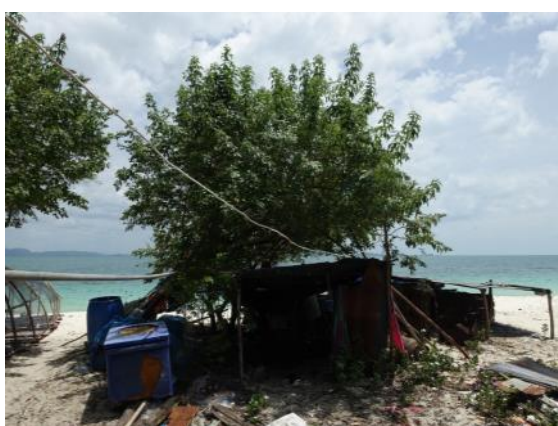
Most of the private generator's grids, which were installed by the locals (between one to five years ago), are very similar. The grids consist mainly of 2x1.5 mm² VAF cables as shown in Figure 29 to Figure 32. The insulation of the cables has been fixed several times, but the repair has not been carried out on a professional basis using regular electrical tape. Exposure to sunlight will dry out the tape which will become brittle or delaminate as a result.

According to Thai Standard, this type of cable should not be exposed to sunlight directly, in other words, this cable should be used for indoor or inside use only.

Figure 29: Grid of Generator #32a

Figure 30: Grid of Generator #33

Figure 31: Grid of Generator #37

Figure 32: Grid of Generator #38

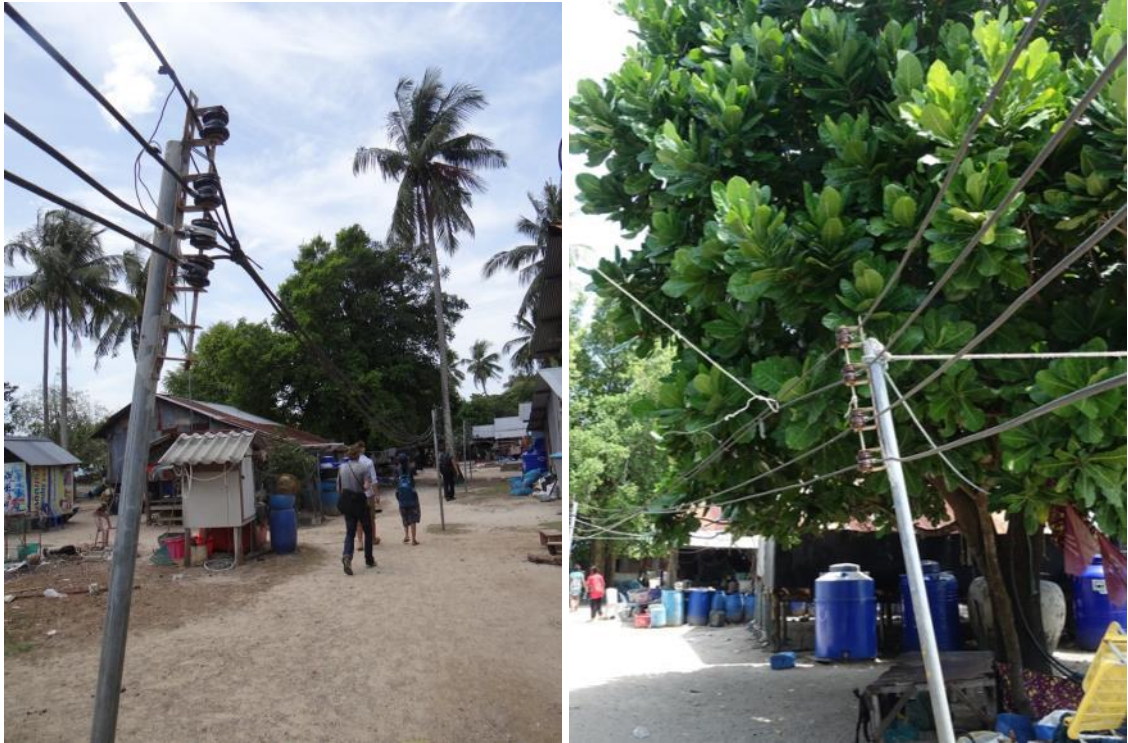
Solid steel poles were installed for the central grid transmission line as shown in Figure 33. However, the cables are connected to the poles in a height between 2 m – 2.5 m above the ground. This may result in cables hanging down between poles in a height that people can touch them by accident, therefore, the steel poles shall be higher, at least 2.5 m according to Thai standards. Other types of poles have also been observed during the site visit as shown in Figure 34.

Figure 33: Steel pole of main grid

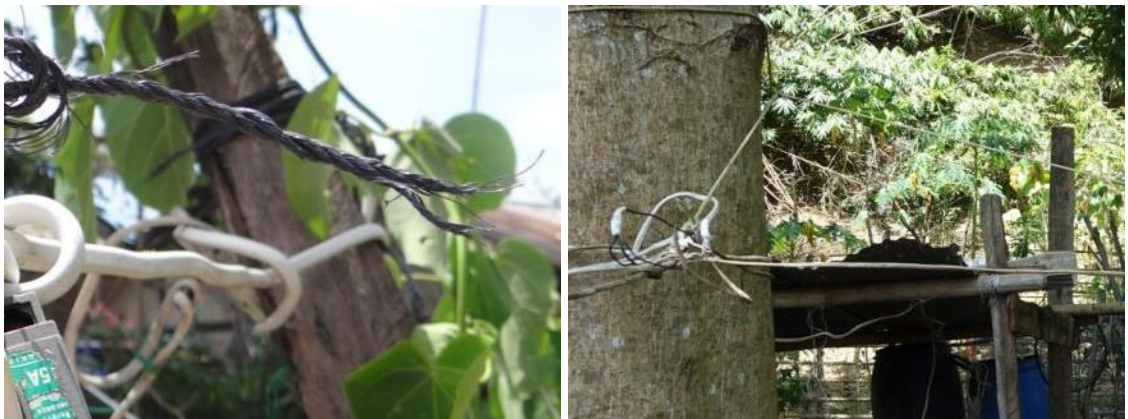
Figure 34: Wooden pole and tree connection of private connections

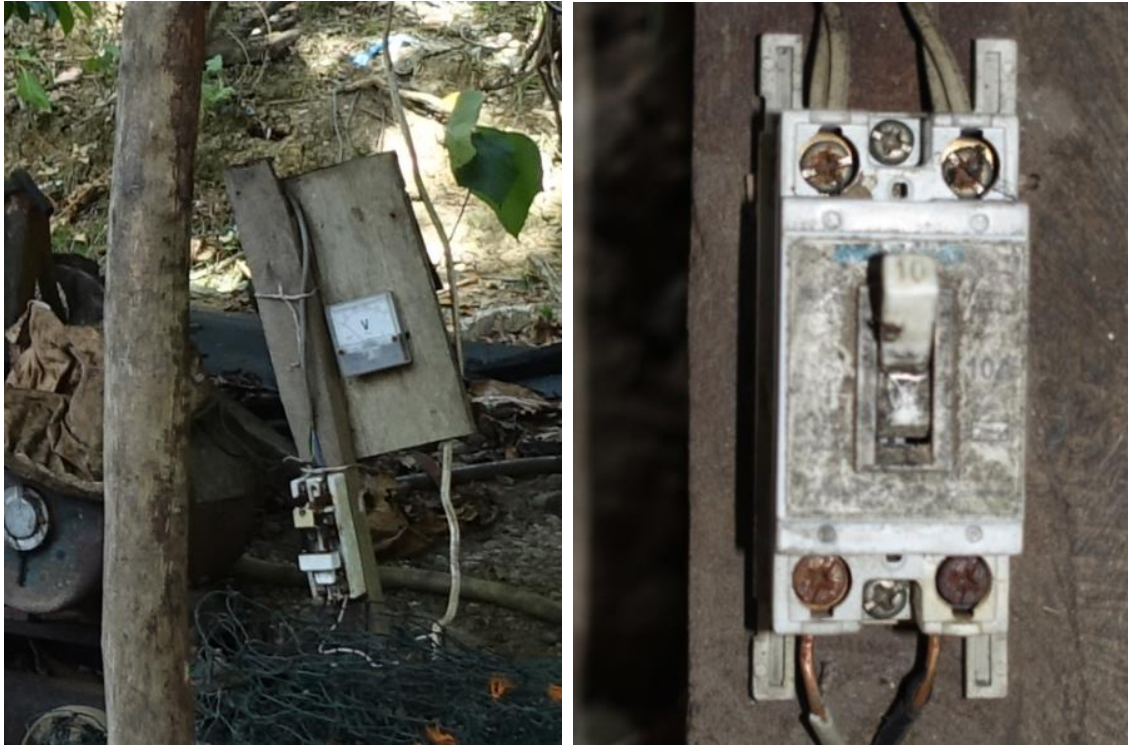
All grids having manual switches installed to disconnect the generators from the load. These switches have the purpose to protect the load from the starting current of the generator. Several of the switches are in a bad condition (e.g. open metal parts), which may result in very dangerous electric shocks, if touched during operation.

Figure 35: Disconnect Switch and Circuit Breaker for Generators

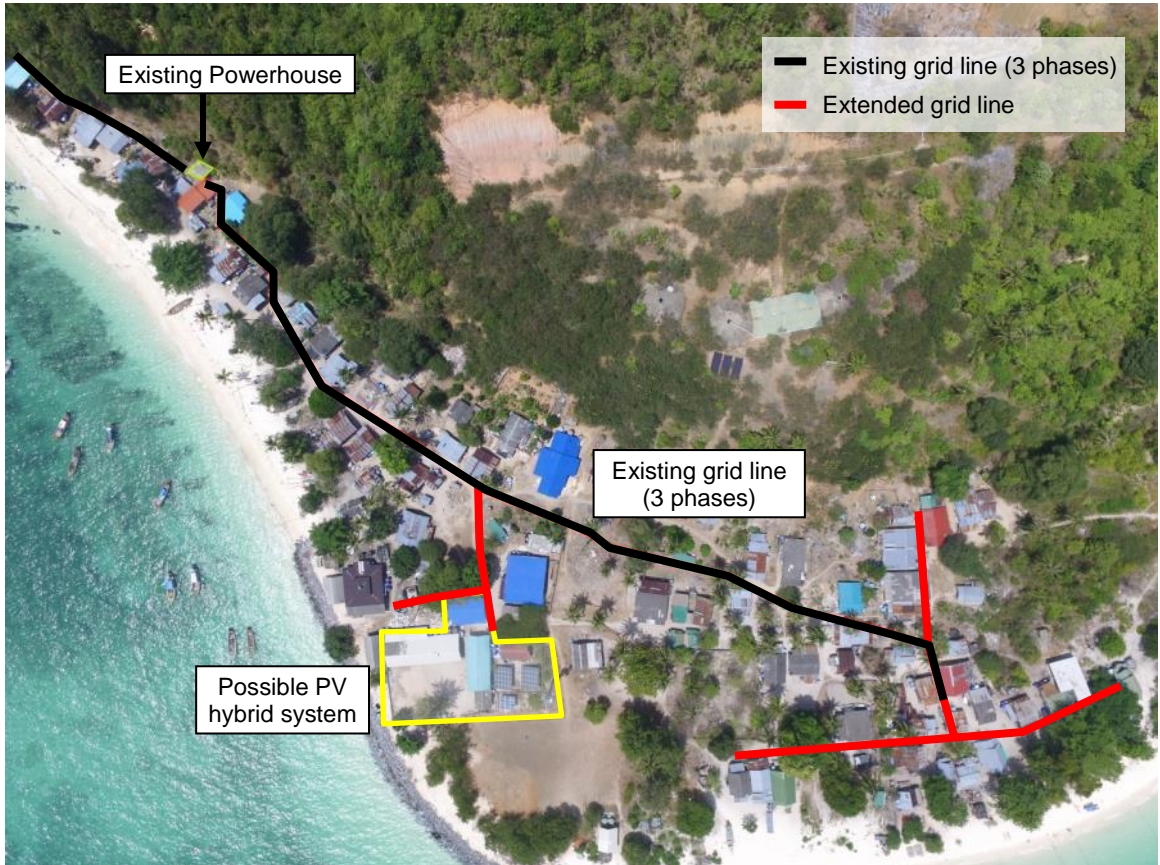
Figure 36 shows an overview of the island with the proposed transmission line route including the extension. The location of the powerhouse needs to be reconsidered as the current location for the community generator is close to some of the households (in the backyard of three houses). The new location is yet to be confirmed and is so far unknown. The existing transmission grid shall be upgraded with new poles with a minimum height of 2.5 m. Cables, fuses and fixtures seem to be in good condition and do not need a replacement. The existing grid shall be extended to cover all households with the length of approx. 300 m as indicated by the red line. The extended line shall be investigated to be either single phase or three phase at a later stage of the Project.

Figure 36: Proposed transmission line on Koh Bulon Don

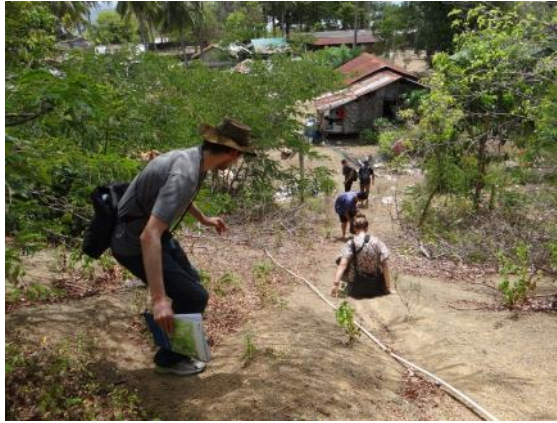
For Area 1-3, it has to be noted that there is a dirt road access to the area, but the road is very steep as shown in Figure 38.

Figure 38: Steep road access to the Area 1-3

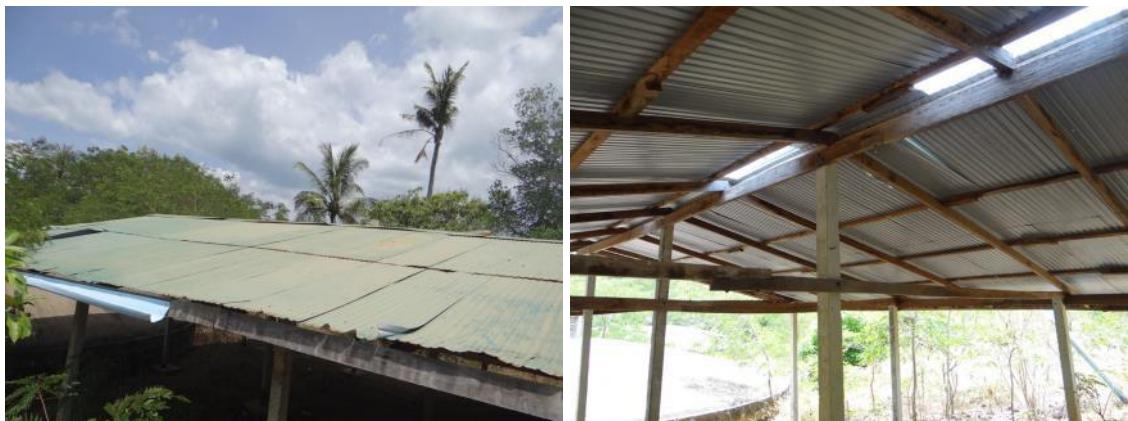
The structure of the roof seems to be too weak for a PV rooftop installation as shown in Figure 39. The roof is facing East-West direction. The structure shall be reinforced and the roof sheet shall be replaced with more durable material. There might be far shading from the mountain in the Western direction.

Figure 39: Structure of the roof of the building next to water storage

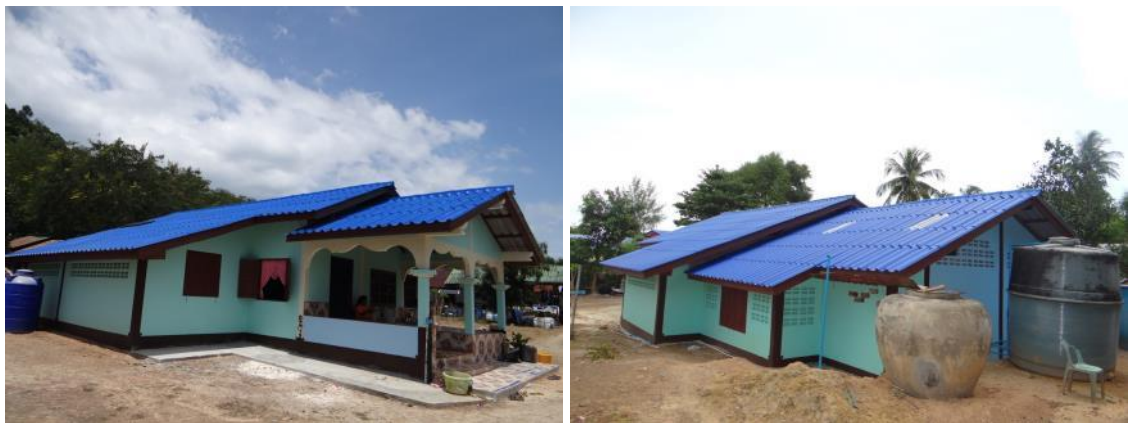
The roof structure seems strong enough to install a PV rooftop system. The roof is facing into North-South direction and has an inclination of 20°. However, the utilization of the roof needs to be discussed with the island deputy. There is possible far shading from the mountain in the Western direction.

Figure 40: Island deputy's house

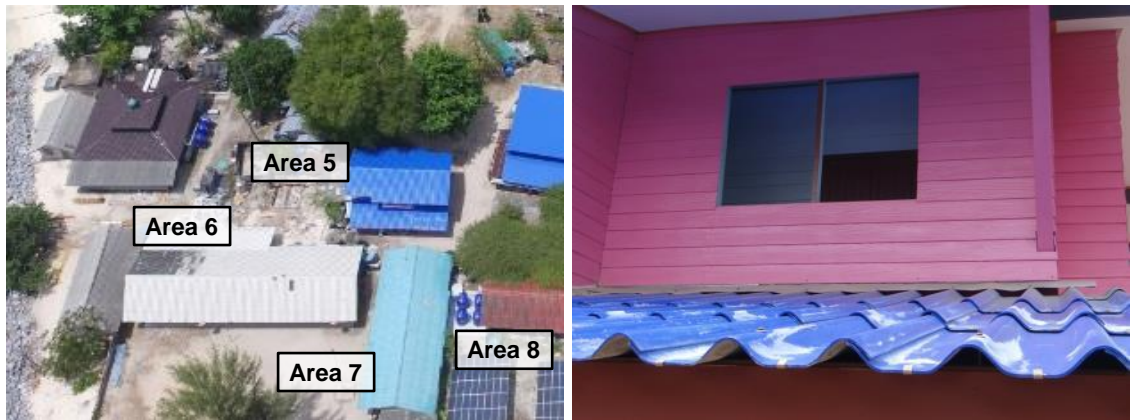
The roof structure seems to be strong enough for a PV rooftop installation. The roof is facing to East-West direction and has an inclination of 20° as shown in Figure 41. Two eight-meter big trees next to the blue roof building have to be considered for shading which affects all roofs (blue, grey and green roof).

Figure 41: Roof overview and roof sheet shape

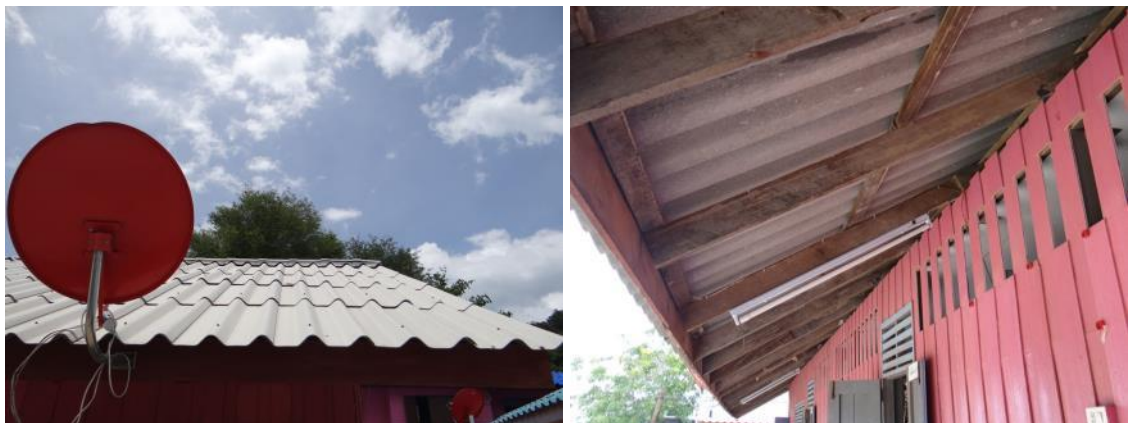
The roof structure looks sufficiently strong to install a PV rooftop system. The roof is facing in North-South direction and has an inclination of 30° as shown in Figure 42. The size of the roof is approximately 25 m \times 10 m.

Figure 42: Roof overview and roof structure

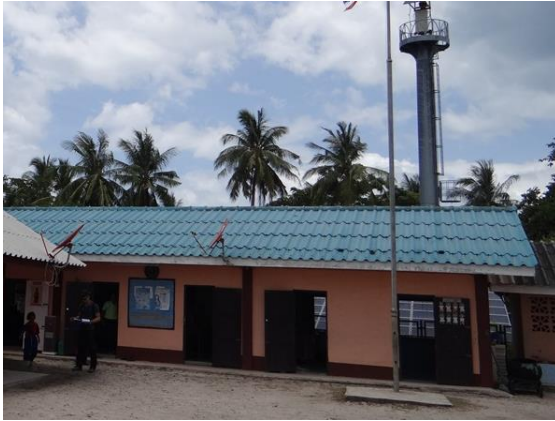
The roof structure looks strong enough to install a PV rooftop system. The roof is facing East-West direction and has an inclination of 20° as shown in Figure 43. The size of the roof is approximately 20 m \times 10 m.

Figure 43: Roof overview

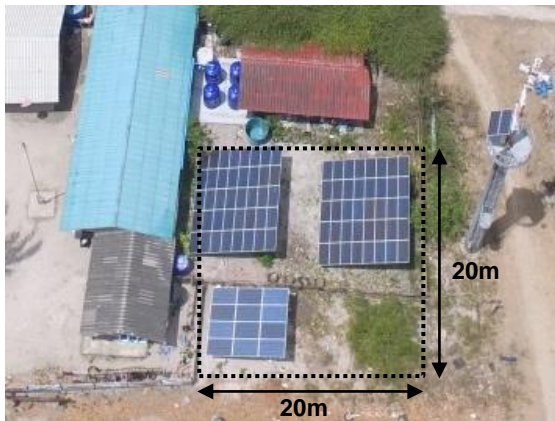
Figure 44 shows the existing PV installation area. The size of the area is approximately 20 m x 20 m. The existing Uni-Solar modules can be replaced with new modules. Shading from the school building shall be considered if the system is being renewed or replaced.

Figure 44: Existing PV area at school

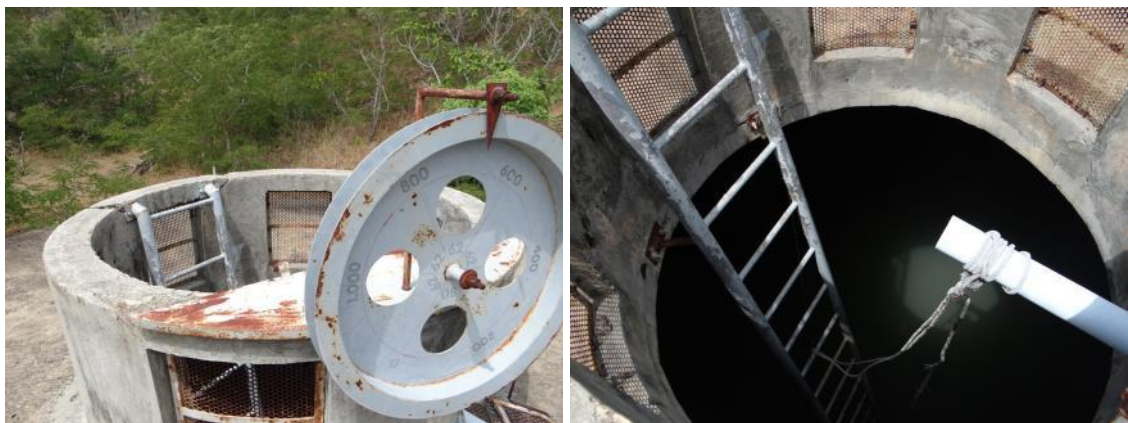
storage concrete tanks of 1,000 m³ capacity each. The size of the lake is approximately 50 m x 15 m x 2.5 m. Most of the households also have individual storage tanks.

Figure 46: 1,000 m³ water storage concrete tank

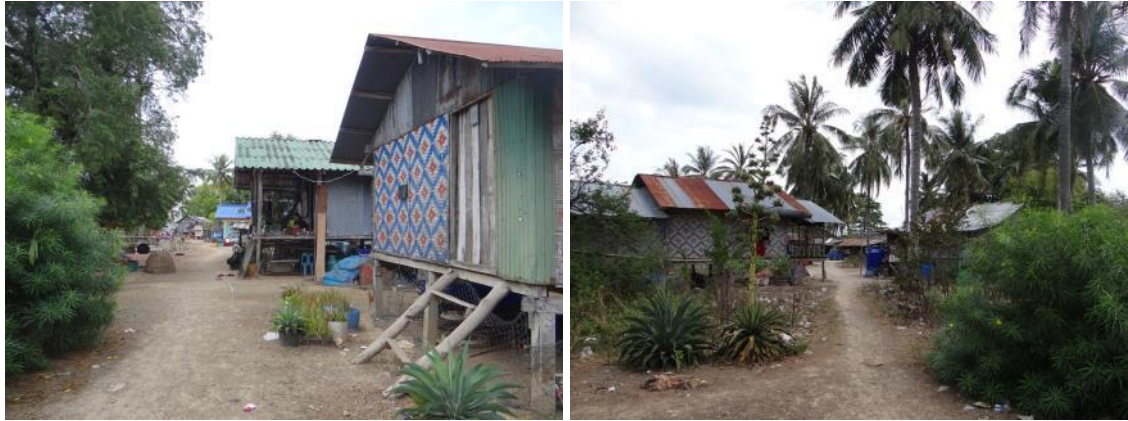
There is no concrete road available on the island, only dirt road.

Figure 48: Dirt road
