Hybridization of Islands, Thailand

SITE VISIT REPORT KOH BULON LAE

18/05/2017

ILF Consulting Engineers (Asia) Ltd

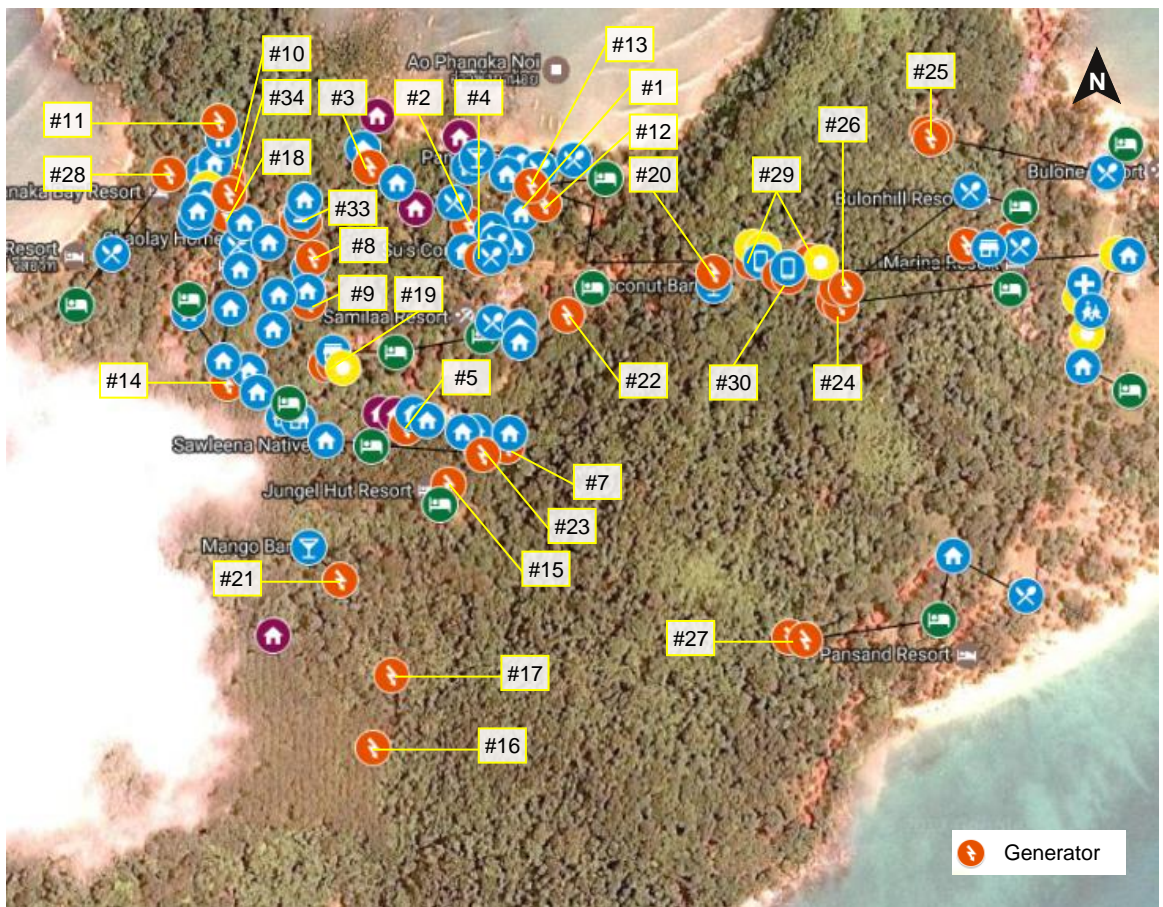
Figure 3: Generator locations observed on the island

On Koh Bulon Lae, basically every resort has at least one generator to power its bungalows and restaurant. Several households are connected to smaller grid infrastructures. An overview of the grid supplying generators and the related grids is given in the following chapters. It has to be noted, that in almost all cases either the motor or the generator or both machines have no nameplate, therefore the power could be assessed only for some of the machines, if at all. In the cases where more than one generator is used, usually one of the generators provides power for the evening, the other one for the night. Figure 3 shows all generators observed on the island during the site visit.

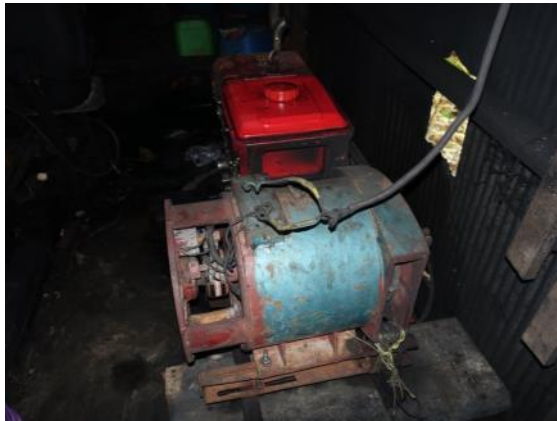
Figure 4: Generator #1 owned by Mrs. Pin

This generator is located near Aao Panka Noi, next to Thanee's house. The engine brand is YANMAR TF 75-LM. The generator nameplate was not readable. There is a power house with a metal roof sheet and the generator is placed on a concrete slab floor. Diesel consumption is reported to be around 5 litres per night. The generator supplies power to 4 houses and 1 restaurant. It is operated by Mrs. Pin and connected to their small grid. The grid was set up more than five years ago and operated since then.

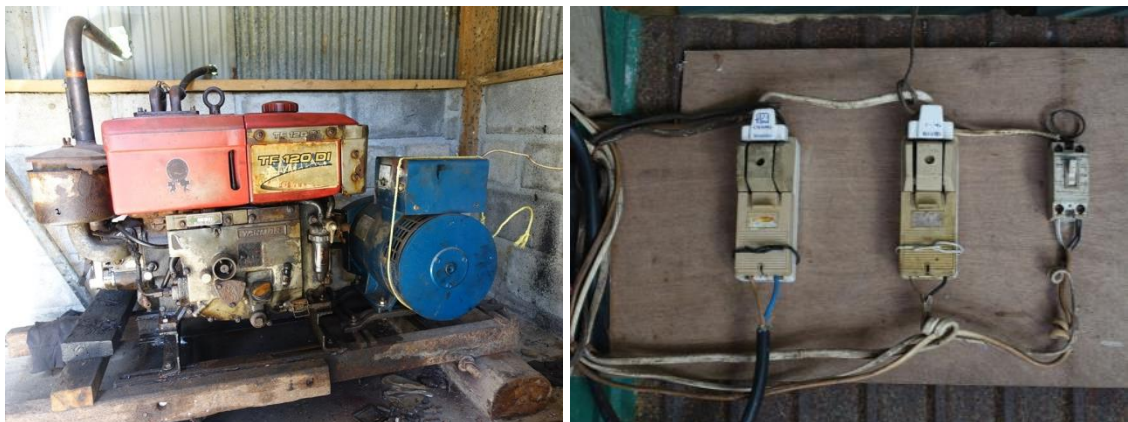
Figure 5: Generator #2 owned by Ms.Yuree/Mr.Mok

This generator is located near Aao Panka Noi, next to the shore. The engine brand is YANMAR TF 120–DI. There is a powerhouse with a metal roof sheet and the generator stands on wooden logs on a concrete slab floor. Diesel consumption is around 5 litres per night. The generator supplies power to two houses, one shop and one bar. It is operated by Mr. Mok and connected to a small grid. The grid was set up around five years ago and operated since then.

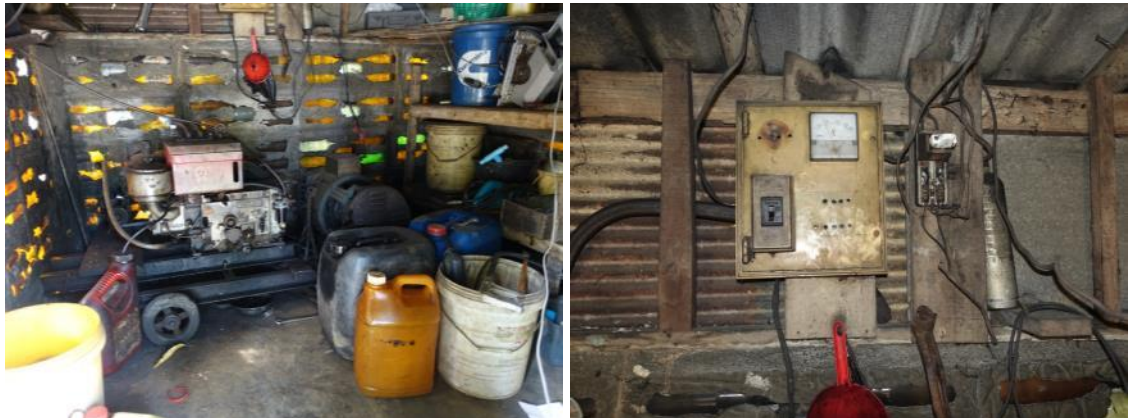
Figure 6: Generator #3 owned by Mr. Ali

This generator is located in Bulon-Lae Village. The engine brand is YANMAR. There is a powerhouse with a corrugated sheet roof and the generator stands on a metal trolley on concrete slab floor. Diesel consumption is around 3 litres per night. The generator supplies power to three houses via a small grid which was set up around 10 years ago. The generator is operated by Mr. Ali.

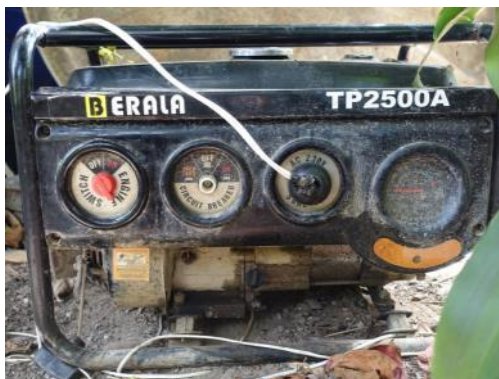
Figure 7: Generator #4 owned by Ms. Suchanya

This generator is located at the intersection between Aao Panka Noi and Aao Panka Yai. The engine brand is BERALA TP25000A. There is no powerhouse and the generator is positioned under trees. Diesel consumption is around 4-5 litres per night. The generator supplies power to 1 restaurant and is operated by Ms. Suchanya. The grid was set up around five years ago.

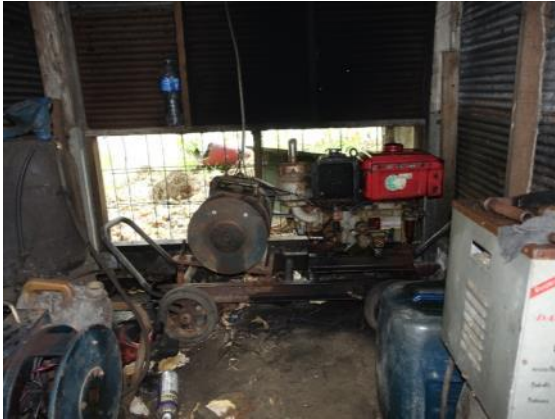
Figure 8: Generator #12 owned by Mr.Sompong

This generator is located near Aao Panka Noi, next to Generator #1 of Mrs. Pin. The engine brand is Yanmar TF 75-HM. There is a small powerhouse with a metal roof and the generator stands on a metal trolley on concrete slab floor. Diesel consumption is around 10 litres per night. The generator supplies power to 2 restaurants. It is operated by Mr. Sompong and connected to their small grid. The grid was set up around three years ago.

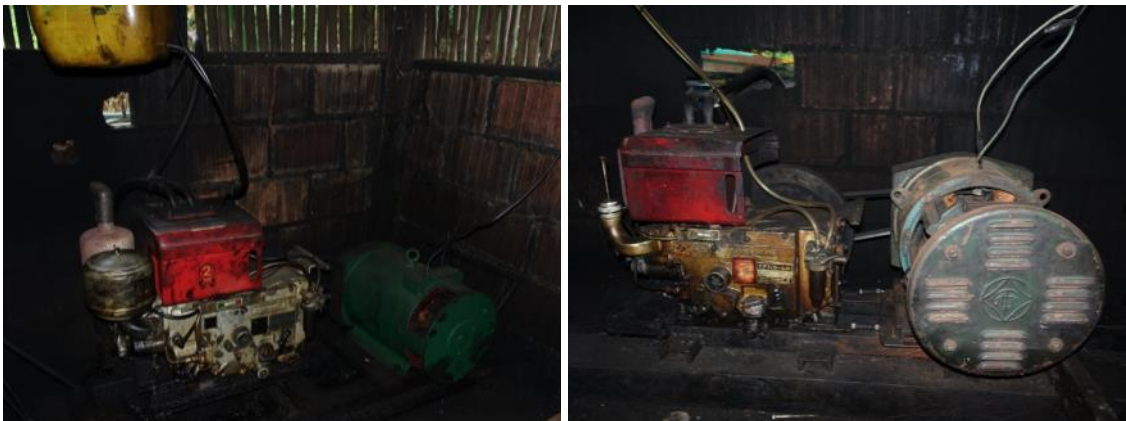
Figure 9: Generator #18a and #18b owned by Chaolae Homestay

There are two generators which are Yanmar TF120DI-H (8.8 kW max output) and Yanmar TF115-LM (8.46 kW max output) as shown in Figure 9 from left to right respectively. These generators were installed inside a small powerhouse with a metal roof sheet. Poor ventilation inside the powerhouse has been observed. The generators supply the electricity to 8 households, 8 bungalows and 1 restaurant. The generators are operated and maintained by Mr. Rit. There is a switch to choose which generator shall be connected to the grid, both generators cannot be connected with the grid at the same time. Diesel consumption is around 13-17 litre/night during high season and 6-9 litre/night during low season.

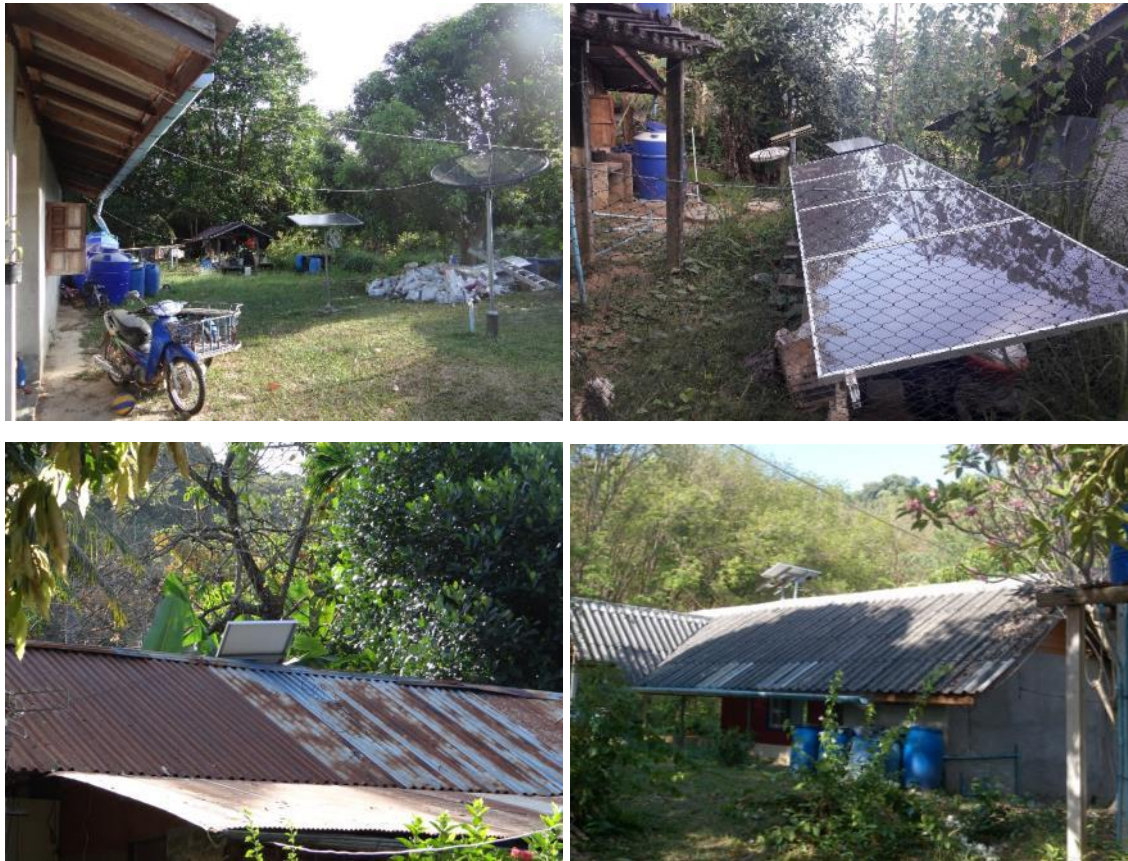
Figure 11 shows the SHS available on the island. There are around 100 SHS provided by PEA in the past, while only approx. 20 modules are still working. The modules are 130 W_p of Northern Sunshine. There are different setups in each household with a SHS: various inclinations, various facing directions, installation types (rooftop setup, ground-mounted), inverters, etc. Some households have SHS with battery storage as shown in Figure 12. Additionally, there were some private initiatives to install solar panels; however, systems are often broken or shaded.

Figure 11: Solar Home Systems observed on the island

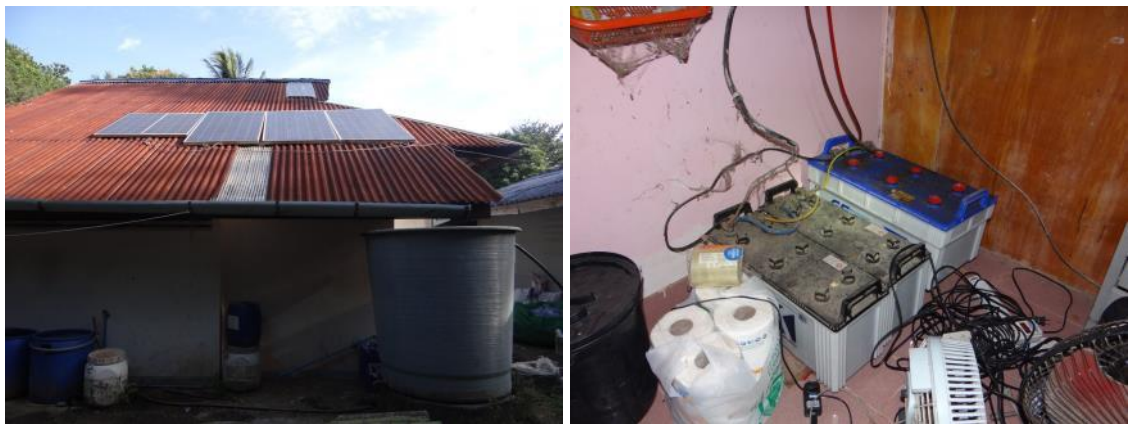
Figure 12: Solar Home System with batteries

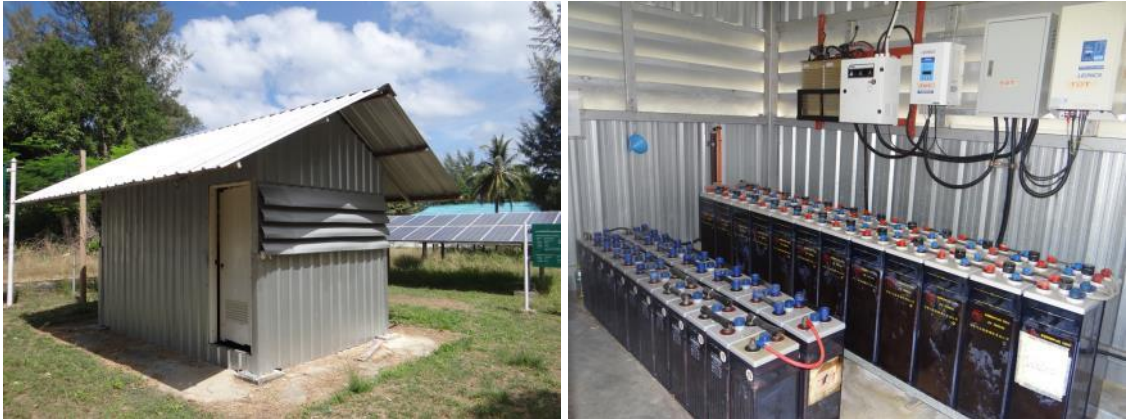
Figure 14: Power house including charge controller, inverter and batteries

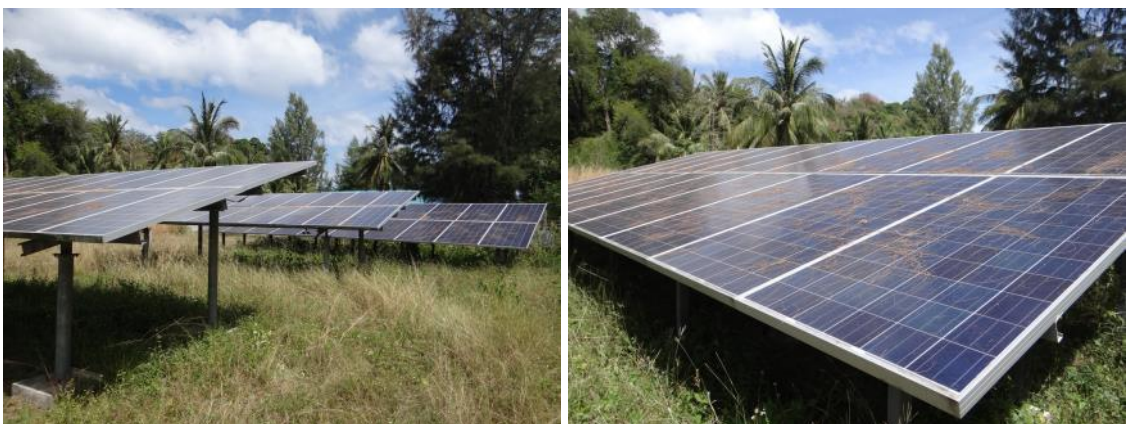
All solar modules are facing into Southern direction with an inclination of 15°. The system is affected by shading from the trees in the East. Dirty PV modules are observed as shown in Figure 15 and the grass is mowed irregularly.

Figure 15: Dirty PV modules observed

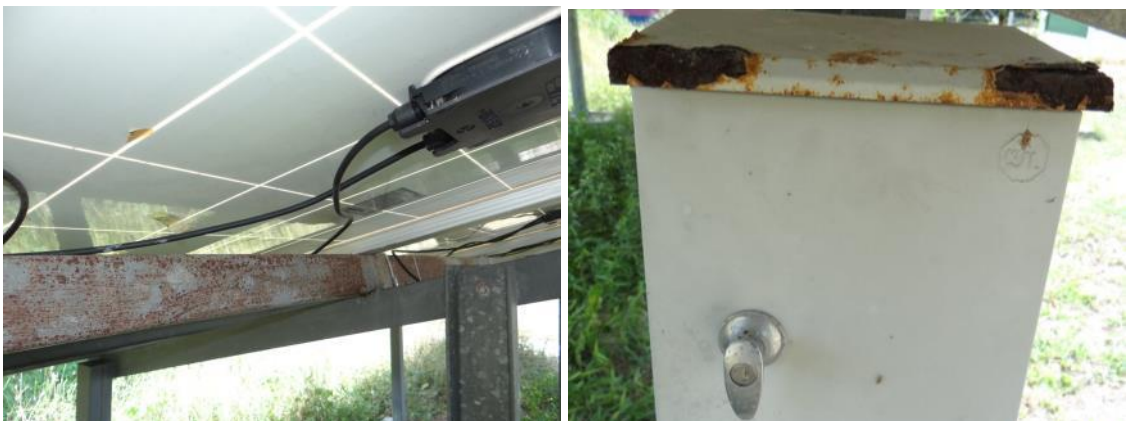
The mounting structure and combiner box are rusty as shown in Figure 16. It can be presumed that the installed material is not corrosion resistant.

Figure 16: Rusty mounting structure [left] and combiner box [right]

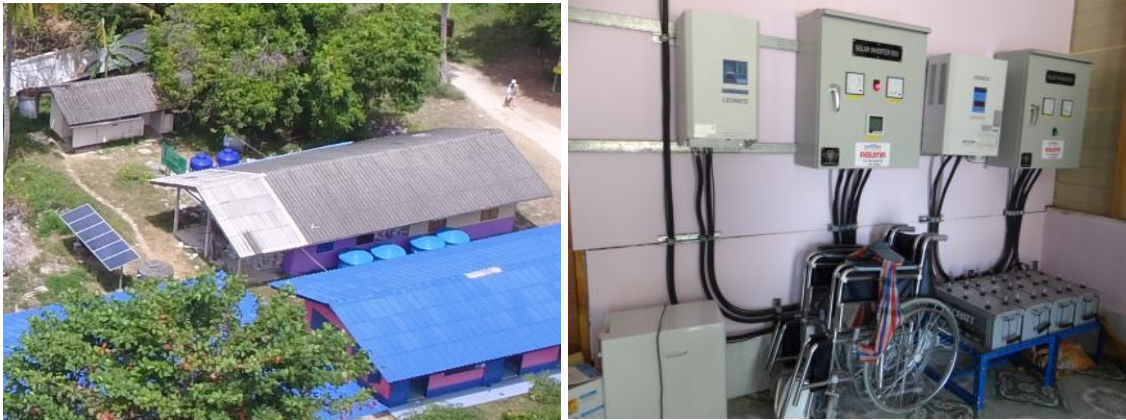
nurse mentioned that the electricity supply is not enough. The medical centre has high wattage appliances oxygen concentrator, rice cooker and electric kettle. The electric kettle cannot be used as the inverter will cut out.

Figure 17: PV-battery system supplying public health centre

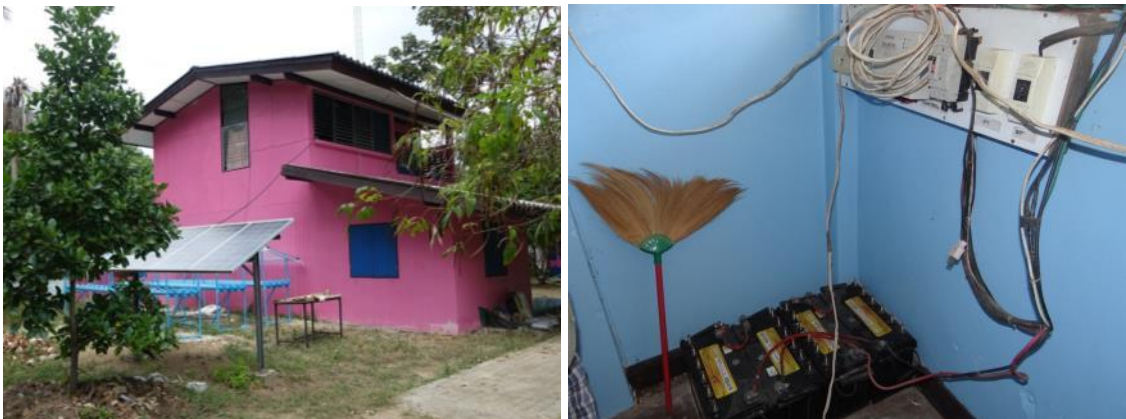
Another PV-battery system is supplying the electricity for the teacher's resting building as shown in Figure 18. The modules are 120 W_p Solartron SP120. The system is facing South. The inverter is currently out of order, the reason is said to be lightning strikes, while PV modules, charge controller and batteries are still working.

Figure 18: PV-battery system supplying the building for teacher resting

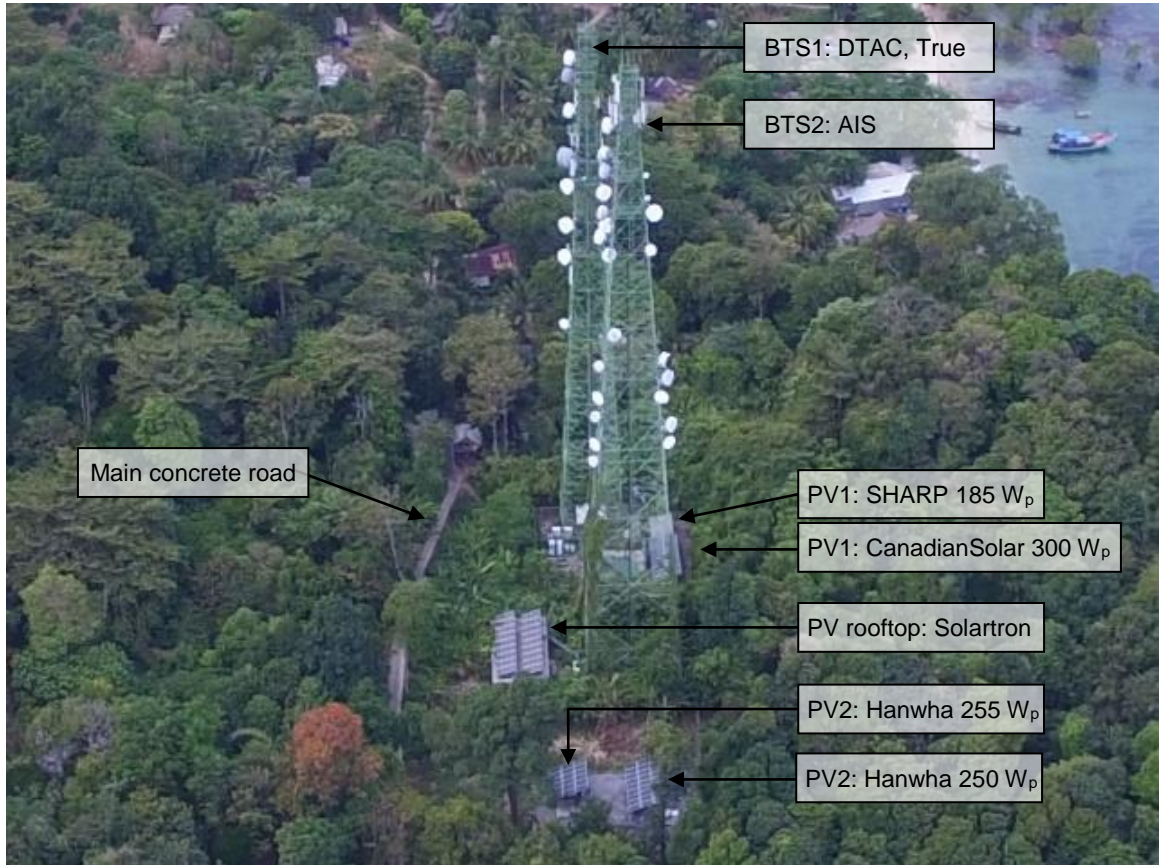
Figure 19: Overview of BTS1 (True,DTAC), BTS2 (AIS) and PV systems

Figure 19 shows the drone picture of BTS1 (DTAC, True) and BTS2 (AIS) including PV systems supplying the electricity for both BTS.

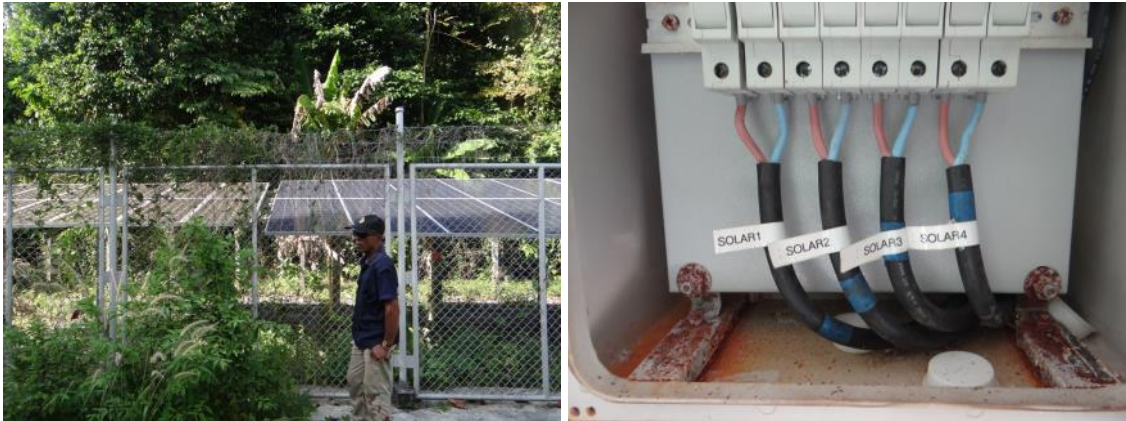
rusty components were observed. Both modules are facing towards South-West direction with an inclination of 15°.

Figure 21: PV system supplying the electricity for the BTS1 (PV1) and rusty components

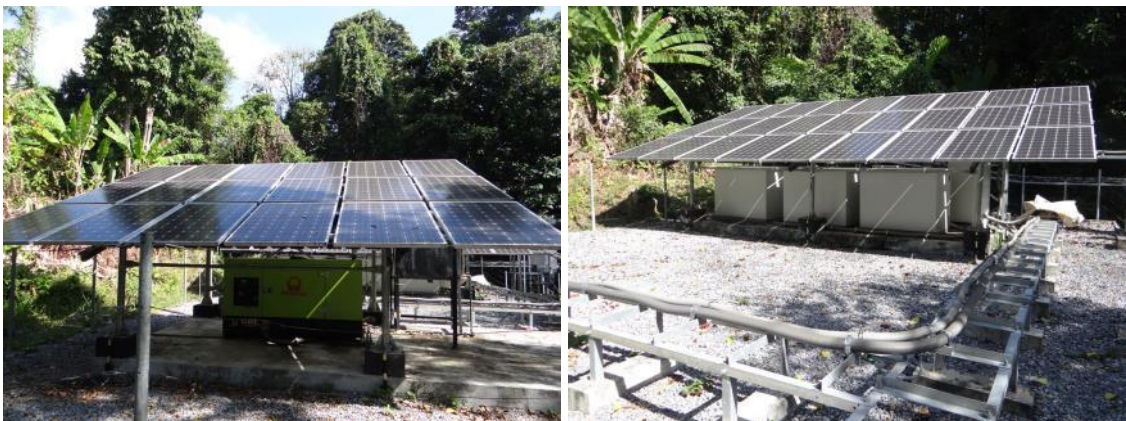
Figure 22 shows the PV system located next to BTS2. The system comprises of 27 modules of 250 W_p Hanwha HSL60M6-HA-1-250 and 18 modules of 255 W_p Hanwha HSL60M6-HA-1-255., totalling 11.31 kW_p. The modules are facing South-West. Poor ventilation for PV modules and rusty flexible conduit were observed as shown in Figure 23. The system is also connected to batteries, shown in Figure 24.

Figure 22: PV system supplying the electricity for the BTS1 (PV2)

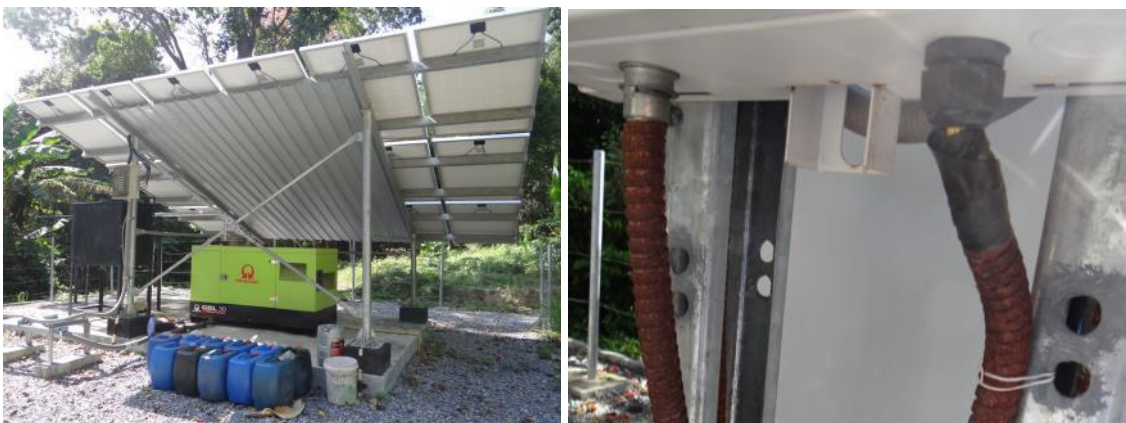
Figure 23: Poor ventilation for PV modules [left] and rusty flexible conduit [right]

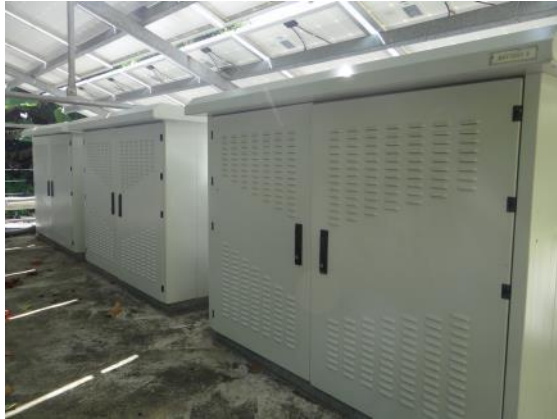
Figure 24: Battery cabinets

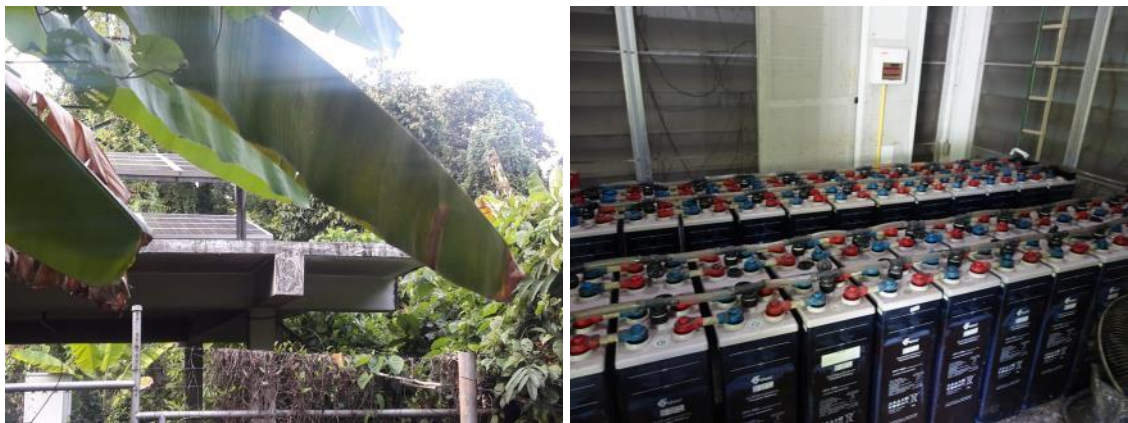
There is a PV rooftop installation supplying electricity to BTS2 as shown in Figure 25. The modules were not accessible. However, the modules might be the same as the system at the school (130 W_p Solartron SP130). The total capacity of the 18 PV modules is therefore estimated with 2.34 kW_p. The system is also connected to the batteries.

Figure 25: PV rooftop and batteries supplying BTS2

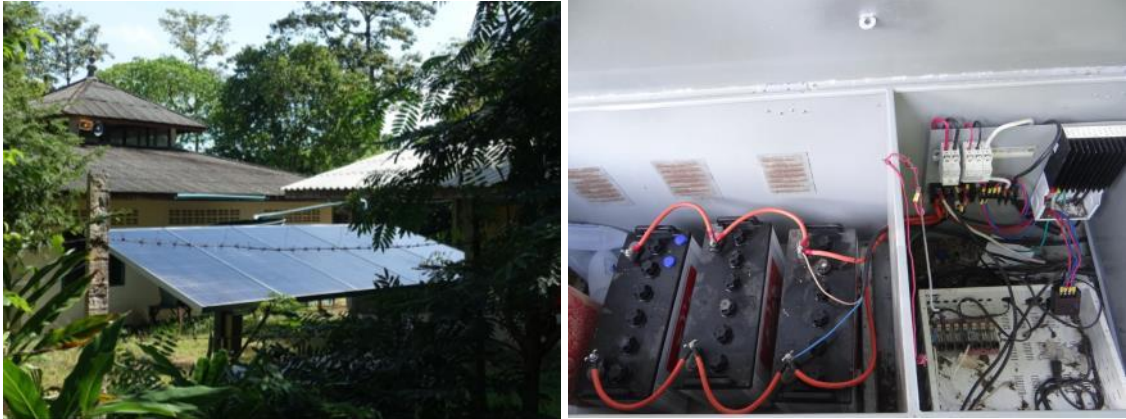
Figure 26 shows the PV-battery system supplying electricity for Bulon Lae mosque. There are five PV modules which are 120 W_p Solartron SP120 connected to 3 batteries. The modules are shaded due to surrounding trees.

Figure 26: PV system located at mosque

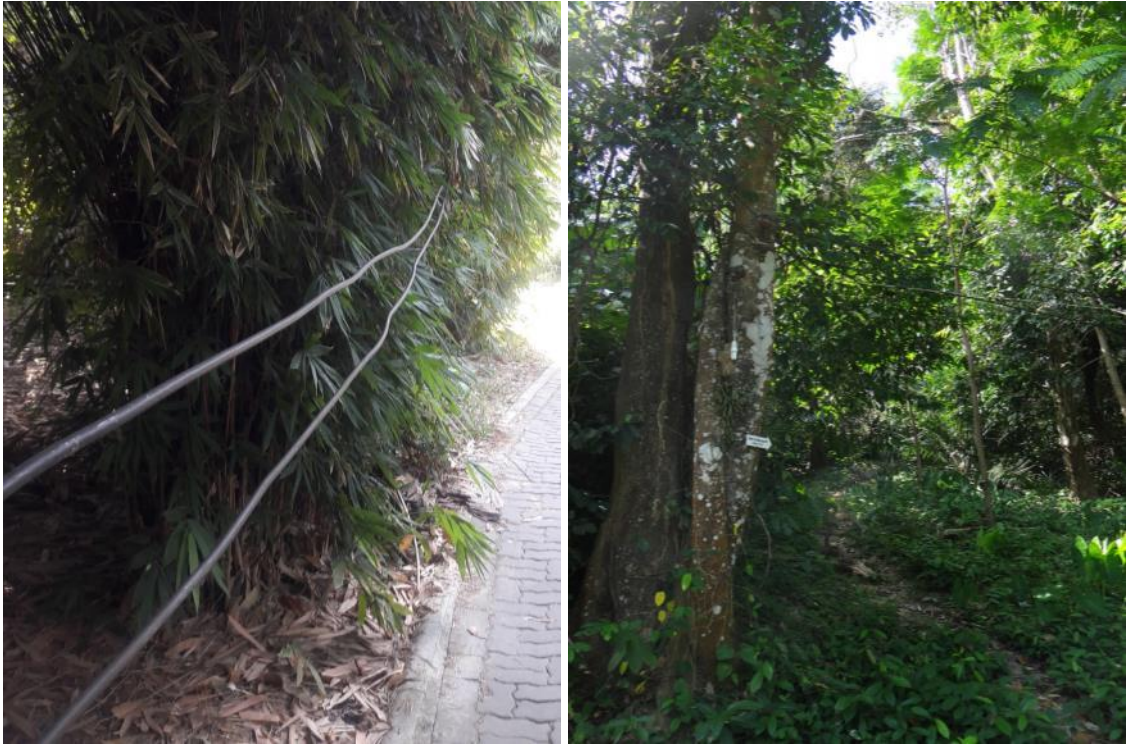
As shown in Figure 28, the poles along the road are wooden or steel type poles with a height of around 2 meters. In some cases, the conductors are fixed to trees. The ownership (BTS operator or private) of the cable could not be clarified. However, any future usage of the grid shall be discussed with the owner. Nevertheless, some poles require replacement or improvement since they are not durable or not high enough.

Figure 28: Grid line from Generator 6 to BTS1

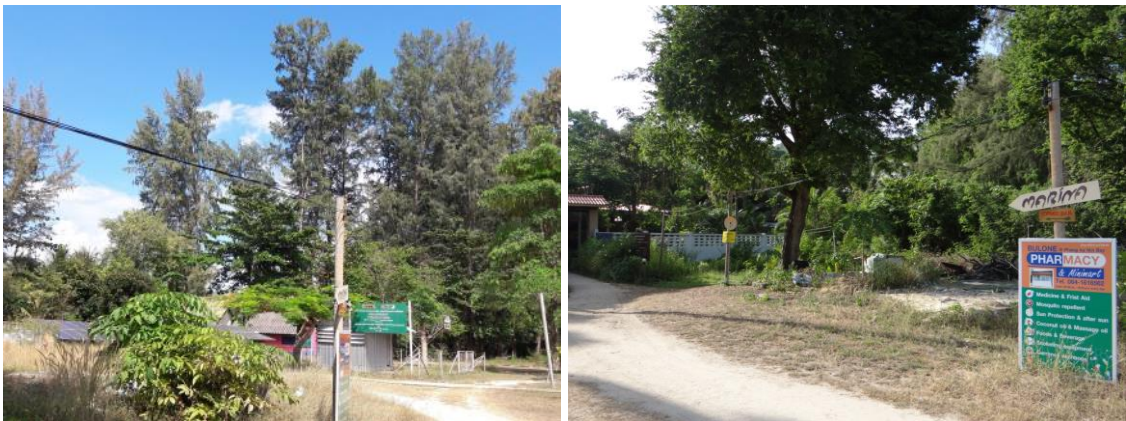
The second larger grid is the connection between the School's PV system and the BTS2 tower. The grid is a single-phase system as shown in Figure 29 and Figure 30. The system is still in operation and the PV system at the school supplies power to the BTS2. Details of the PV system are described in Chapter 5.2. The conductor is a 10 sq.mm THW-A, Bangkok Cable in good condition. The steel type poles are in good conditions; however, they are less than 2 m high. The poles might be replaced or rectified. The final conductor size shall be confirmed and a replacement might be necessary. It needs to be clarified if the existing grid could be used as a public grid.

Figure 29: Grid line from school PV system to BTS2

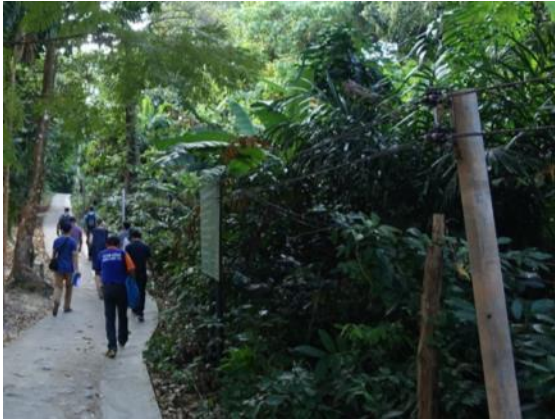
Figure 30: Grid line along pathway to BTS2

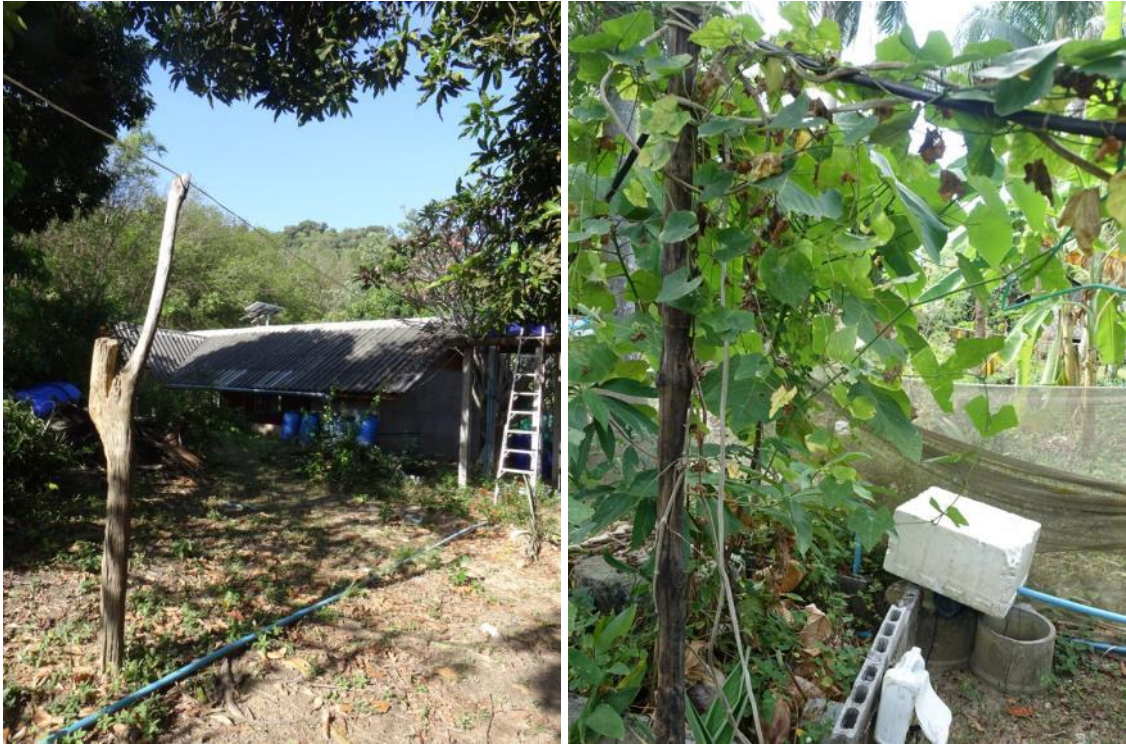
The cables are usually connected to the poles in a height between 2 m – 2.5 m above the ground. This result in cables hanging down between poles in a height that people can touch them by accident.

Figure 31: Wooden stick as a pole and tree connection

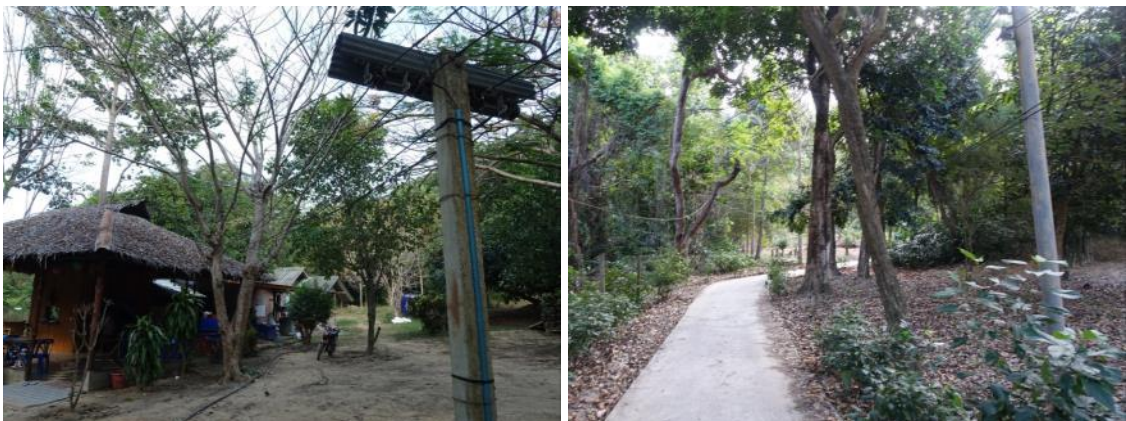
Figure 32: Concrete pole at Similan Resort [left] and steel poles towards BTS2 [right]

The recommended type of pole for the new transmission line is concrete or wood.

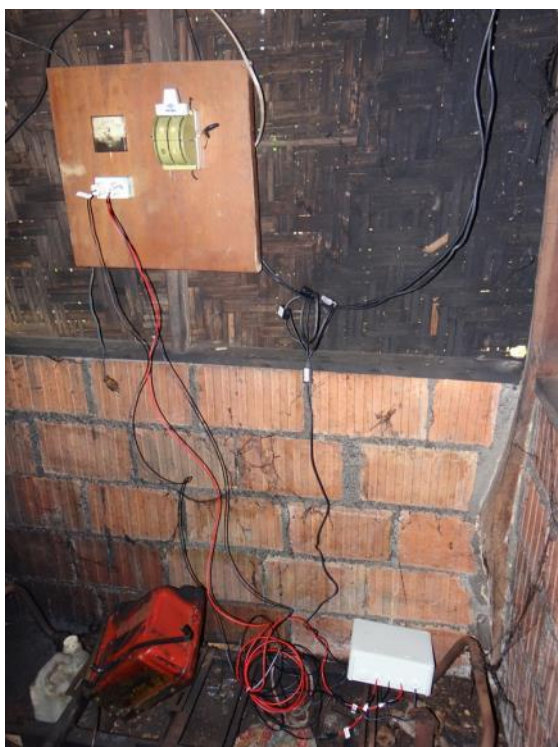
Parameter	Value
Generator Set 1	
Owner and Operator	Chaolae Homestay
Motor type	YANMAR TF 115 – LM
Continuous Motor Power [kW]	7.2
Power Factor	Unknown
Number of phases	1
Frequency [Hz]	Unknown
Fuel	Diesel
Operating hours	6 pm – 10 pm
Age	> 5 years
Generator Set 2	
Owner and Operator	Chaolae Homestay
Motor type	YANMAR TF 120DI – H
Continuous Motor Power [kW]	7.7
Power Factor	Unknown
Number of phases	1
Frequency [Hz]	Unknown
Fuel	Diesel
Operating hours	10 pm – 6 am
Age	> 5 years
Grid	
Number of connected households	- 8 residential houses - 8 bungalows - 1 restaurant
Cables	10 sq.mm THW-A
Poles	Trees, wooden poles and directly between houses
Condition of the cables	In good condition
Age	> 5 years

Figure 34: Load measurement LAE 1 at Generator #18

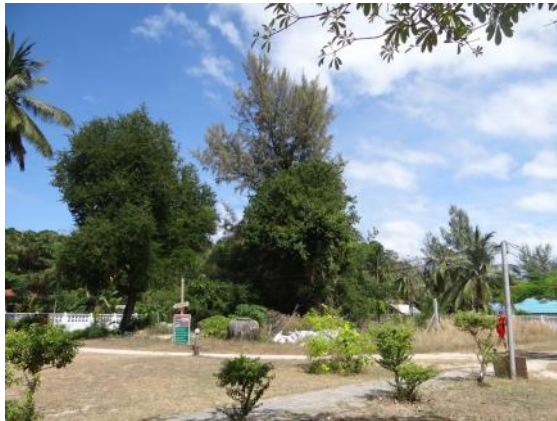
Figure 35 shows the drone picture of Area 1. In case this area will be used, proper coordination about the exact size (width x length x height) and position of the new public health centre has to be carried out before defining the PV panel positions. Cutting down the trees within this area (see Figure 37) is permitted.

Figure 37: Overview of the new public health centre area

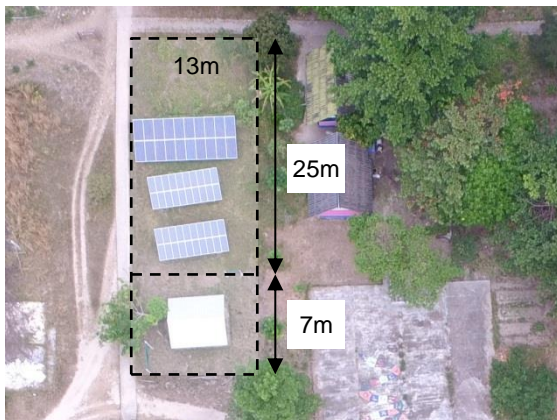
Figure 38 shows the drone picture of Area 2. High trees are located in that area provoking some shading in the morning time.

Figure 38: Overview of existing PV at school with area boundaries

For Area 1 and Area 2, shading analysis shall be conducted due to the surrounding trees. Especially trees in the East side (No.6) may cause some shading. The shading might be however limited to the morning period.

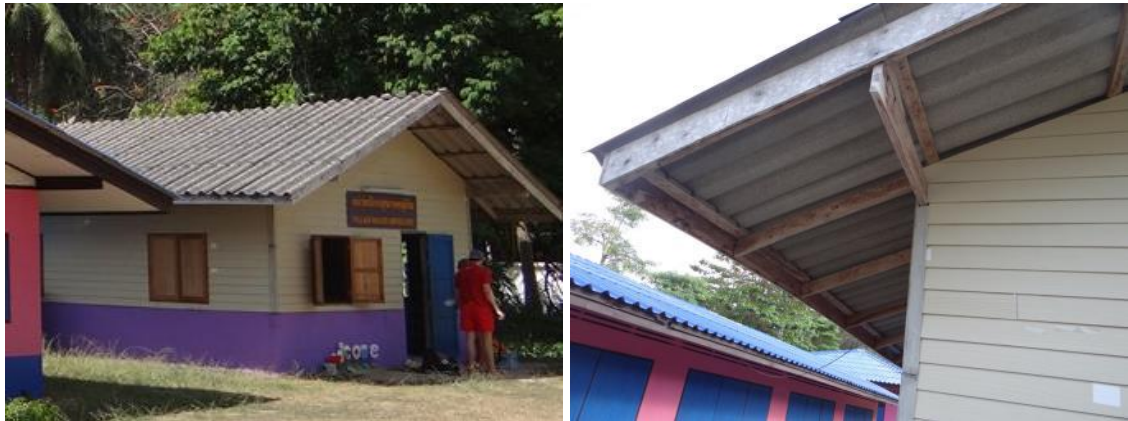
Figure 39 shows the rooftop sheet and structure of the public health centre. It is a gable roof which has slopes on two sides facing towards East-West direction with an inclination of 15°. The approx. size of the roof is 17 m x 9 m.

Figure 39: Rooftop sheet and structure of the public health centre

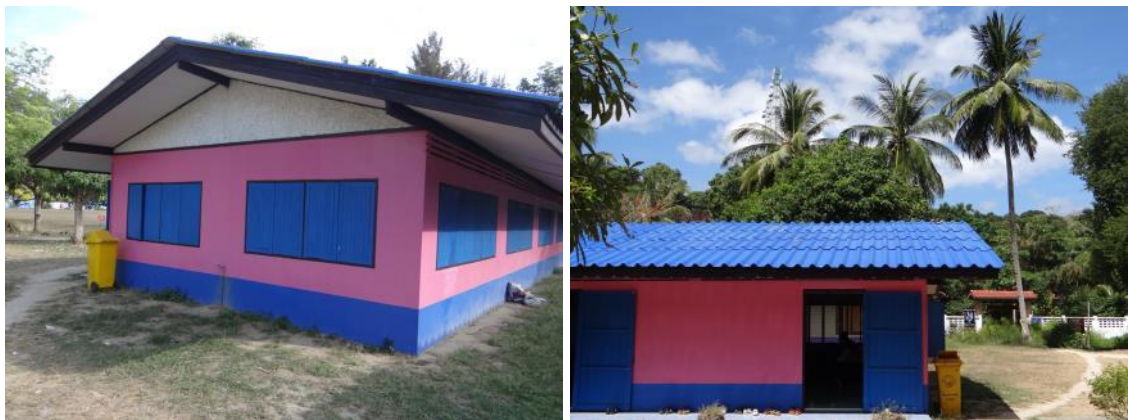
Figure 40 shows the rooftop sheet and structure of the classroom building. The roof's configuration is similar to Area 3. However, it seems to be newer.

Figure 40: Rooftop sheet and structure of classroom building

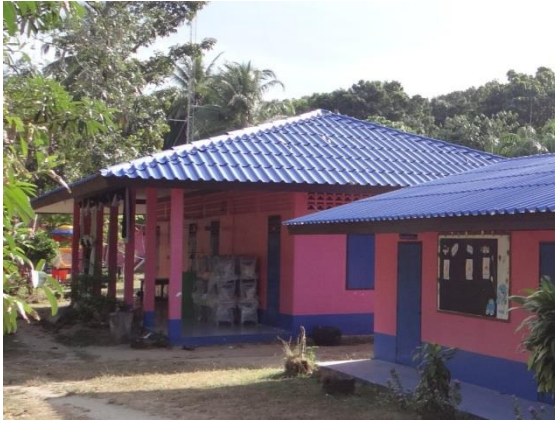
Figure 41 shows the rooftop of the school's main building. The type of roof is a hip roof which has 15° slopes on all four sides. The approx. size of the roof is 20 m × 11 m. There are high trees in the Eastern direction that could provoke shade in the morning time.

Figure 41: Rooftop of school's main building with approximate sizing

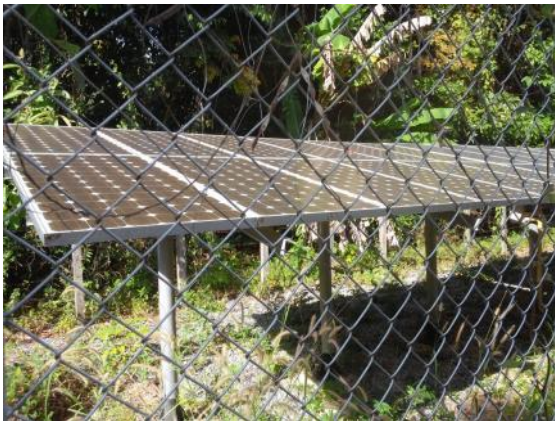
Figure 42 shows twelve broken SHARP modules at BTS1. The approx. size of the area is 3 m x 5.5 m. The usage of the area for a new PV installation shall be clarified with the BTS operator and owner since the connection of a BTS to a hybrid might be complicated and includes several legal and technical impacts. Furthermore, the current ownership/lease-agreement of the land needs to be considered. Therefore, the area shall be least favourable and it is suggested to only consider the area if no other option is available.

Figure 42: Twelve broken SHARP modules at BTS1

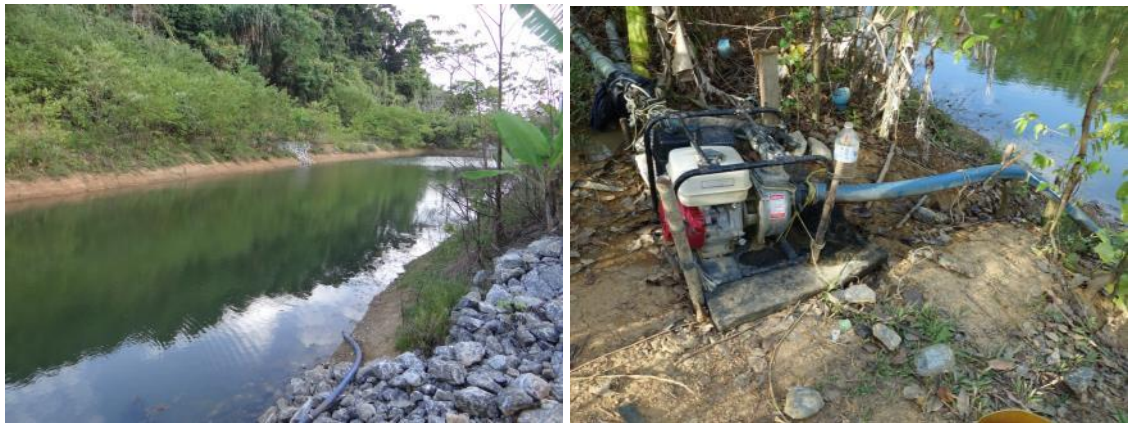
Figure 43: Large pond with water pumping

The diesel water pumps might be replaced with a solar water pump in the future.

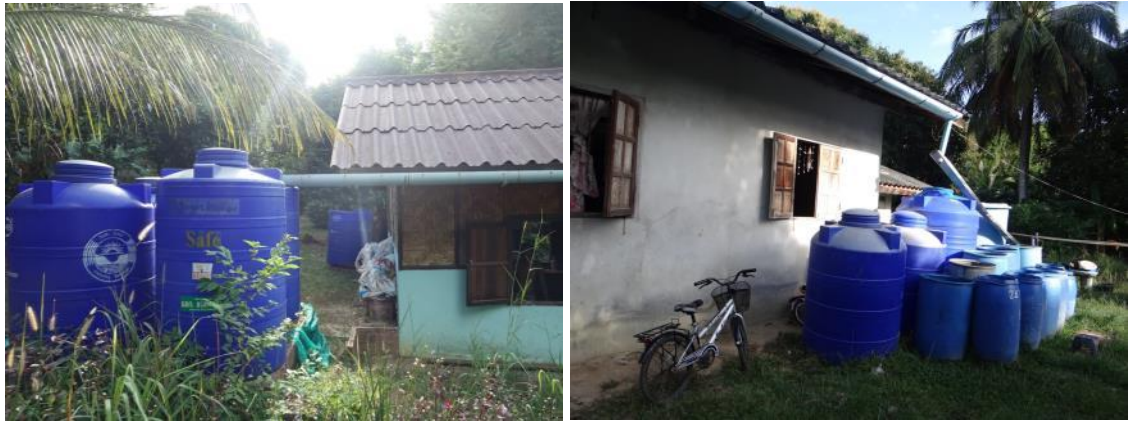
Private storage tanks to collect rainwater have been observed in most households as shown in Figure 45.

Figure 45: private storage tank collecting rainwater
